FASTER THAN A SPEEDING BULLET

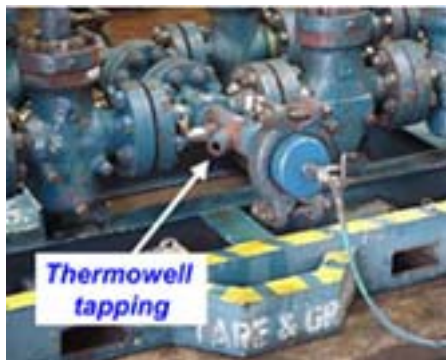
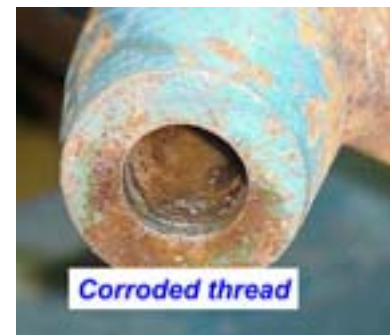
A piece of equipment was being pressure tested at approximately 5,000 psi. During the pressure check, two employees were inspecting for leaks. Without warning, a 3/4" threaded thermowell failed at the threaded joint, the force separated it at a very high rate of speed and it struck one of the employees in the leg, leading to a very serious injury.

- threaded connections can be weak points, especially if the threads are corroded, stripped or if the threaded connection is not fully made up
- these problems are often hidden from view; finding a problem may be possible only if the connection is disassembled and all threads inspected
- in the above incident, what made the accident very serious was the fact that someone was standing right in front of the thermowell when the joint failed

- While complete failures of joints are rare, they can and do occur. In this incident, the force on the thermowell was approximately 1-3/4 ton, and the failure propelled the thermowell at roughly **90 MPH**. When increasing pressure in equipment attempt to stand a safe distance away or behind barricades until the final pressure is reached.
- Whenever threaded connections are disassembled, inspect **BOTH** sets of threads for corrosion, signs of cross threading, etc. If there is a problem, get it repaired before putting pressure on the joint.
- Threaded connections can be "backwelded" - this will improve the overall strength of the joint. The disadvantage, of course, is now the joint can not be disassembled easily.
- For systems where significant corrosion is present, flanged connections are generally better than threaded.

When threaded equipment is taken apart, look carefully for stripped threads, corrosion or anything that looks abnormal – it may be a WEAK POINT in your system!
