Misalignment + Corrosion = Failure!

July 2004

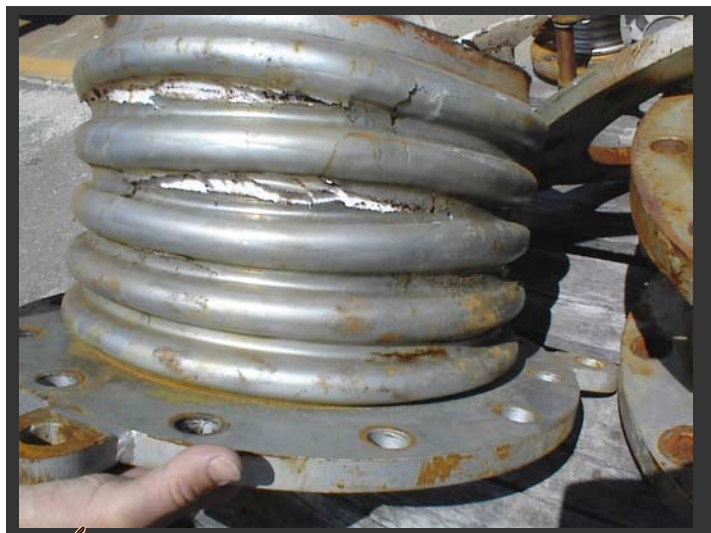
This TFE lined stainless steel expansion joint was part of a piping system containing a high concentration of HCl. The expansion joint was not installed properly and HCl had embrittled the stainless steel bellows. This embrittlement along with fatigue caused by improper alignment and insufficient restraint caused the joint to fail. The catastrophic failure you see in this picture occurred the day after it passed a visual inspection. Fortunately, the system pressure was low, the leak was small, and no one was around when it failed. In this case, there were no injuries. However, if the circumstances had been only slightly different...

- The piping to the vessel where this expansion joint was used was misaligned by approximately $\frac{3}{4}$ inch. This caused stress on the expansion joint.
- The three retaining bolts that limit compression and extension were not installed on the expansion joint because of space limitations. This allowed excessive movement and placed even more stress on the joint.
- The specification for this joint had changed during a retrofit of the process for a new chemical service, but the expansion joint was not replaced with one of proper specification, requiring a higher grade of stainless. This likely contributed to the HCl embrittlement of the stainless steel making it prone to stress cracking and failure.

- ✓ Expansion joints are precision engineered equipment and **MUST** be installed correctly!
- ✓ Ensure that all equipment is installed per manufacturer's specifications!!! Use the facility's management of change (MOC) process to review ANY modification or change.
- ✓ When making visual inspections, note every change from previous inspections and notify the inspection department of those changes. *Protect yourself against sudden failure during the inspection.* Sometimes visual inspection while the equipment is in service is not enough. The equipment may have to be disassembled or simply replaced at a defined interval.
- ✓ Know and plan around common causes of failures:
 - 1) Expansion joints are usually weak spots in piping systems.
 - 2) Misalignment may cause stress cracking.
 - 3) HCl embrittles stainless steel.

Inspection and maintenance programs should not overlook common causes and expected failure modes for expansion joints.

Expansion Joints have Design Limits—Make Sure they are not Exceeded !
