Drill Line Clamp Failure

SAFETY ALERT

ISSUE #: 16-2014

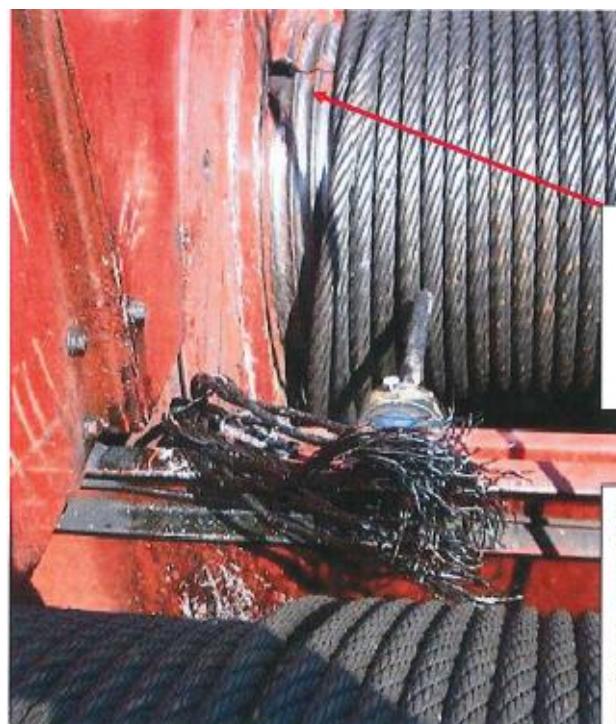
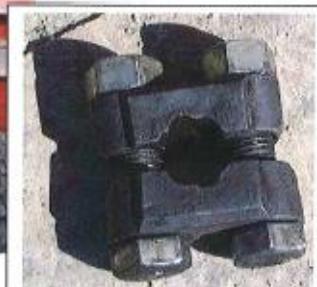
Figure 1
Drawworks,
End Line
and Inset
Clamp

While tripping tubing into the hole, the Driller heard loud bangs from the drawworks. He saw that the end of the drill line had become unsecured, and was spinning around loose in the drawworks causing the noise. The Driller immediately stopped operations and secured the rig, then cleared the floor. Figure 1 below, shows the drawworks with the frayed end of the drill line. The fraying was determined to have occurred after the clamp let go, and was a result of the line rotating freely. The blocks did not fall, and only minor equipment damage occurred, but the potential for possible serious injury was HIGH.

- Inadequate or improper tightening of the drill line clamp.

- The requirement for TORQUE specifications on the clamp was not known. Our TRA #49 – Slip and Cut procedure is to ensure line clamp is tight and installed correctly but does not give the manufacturers TORQUE specifications of 150 foot-pounds.
- The TORQUE requirement was not communicated from the drawworks manufacturer, through the rig carrier builder, to the company.

- All drill line clamps of this type must be removed, inspected and re-installed using the 150 foot-pound torque requirement. Discard the clamp and replace it if any damage is seen or suspected. Obtain any replacement clamps ONLY through the Company, so we can ensure that a clamp acceptable to the manufacturer is provided.
- These clamps are direction-specific. There is a line on the side of the clamp (both saddle parts) that goes to the "live" side of the drill line, not the tail end.
- The grooving in the clamp ensures good grip. As the clamp is installed and tightened, the grooves must have good contact.
- During a Slip and Cut, some tape should be left on the line to secure strands, and when installing the clamp, at least 1.5 to 2 inches of line much be left sticking out on the "dead" side of the clamp.

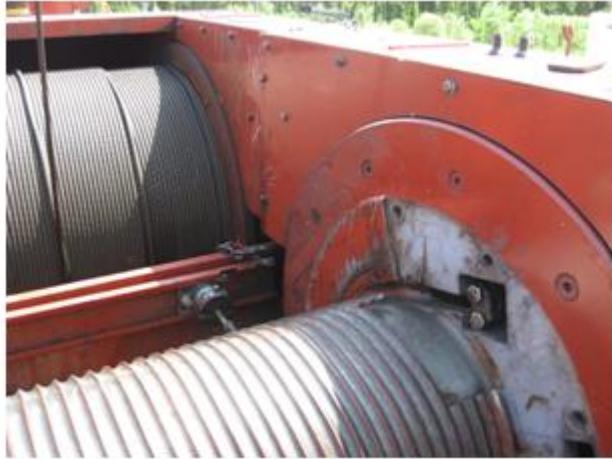
Figure 2 Drill Line Clamp
In Place Position

- A Slip and Cut had been performed prior to tripping out, and the incident occurred during the trip back in.
- Adequate wraps (7+) were on the drum after the slip and cut, and approximately 28 wraps were on the drum at failure.
- A pull-test with the actual line and clamp only caused failure at over 30,000 lbs and caused severe damage to the clamp. An additional test with another set also failed at over 30,000 lbs pull.
- Excessive pull did not appear to be a contributing factor.
