**SAFETY ALERT - #24 - 2009**  
**Hydraulic Annular Control Valve Failure**  
**RELEASE DATE: NOVEMBER 30, 2009**

<b>Function:</b> Production Operations	<b>Incident Date:</b> October 2, 2008
<b>Incident Type:</b> Equipment Failure	<b>Country and Region:</b> Western Canada

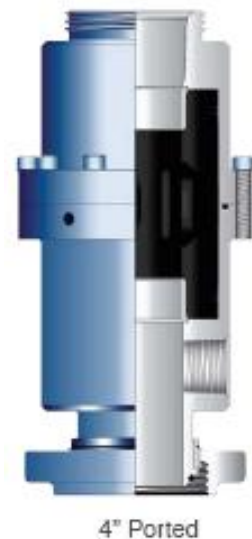
A hydraulic annular control valve, similar to the one shown below, was being used as the primary well control device immediately above the wellhead. A combination of overpressure on the hydraulic annular control valve and mechanically induced movement of the coil tubing siphon string resulted in a failure of the annular bag. Tools across the master valve prohibited its use as a well control device in this circumstance.

- Hydraulic annular control valve assemblies are not recommended as the primary well control Blowout Preventer.
- The hydraulic annular control valve is not designed for continuous use for tubular isolation. There must be a secondary well control device in place.
- Well control devices should be positioned as close to the wellhead as physically possible.
- Well control set up and installations should be aligned with current industry recommended practices and identified in the following:
  - ERCB Directive 37 [Directive 37](#)
  - Well Service BOP Manual Chapter 4
  - IRP 21 pending issuance in 2009 [IRP 21 Coiled Tubing](#)
