Injector Assembly Kicks Out of BOP Injury Incident

SAFETY ALERT

ISSUE #: 13-2012

Release Date: November 17, 2012
Incidence Type: Injury
Country and Region: Alberta, Canada

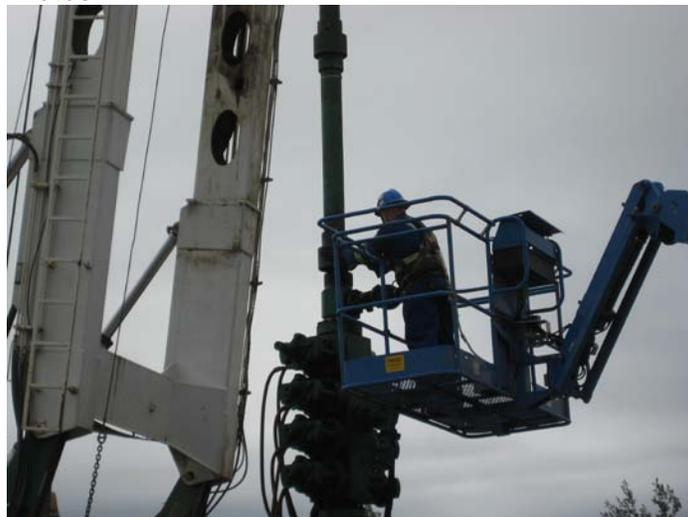
The rig manager was following the operator's directions, and because there was weight pulled into the lube assembly, the rig manager hit the correct spot and the lubricator assembly sprung free of the BOP stack and sprung backwards, striking the operator in the Genie lift in the face and knocking him down.

Image 1 is the position of the employee before being struck.

- The company will endeavour to find an engineering solution to prevent the lube from kicking out of the BOP.
- The JSA procedure has been changed, to identify the hazard and ensure all personnel are clear before the lubricator assembly is lifted off the top of the BOP stack.
- The company will also reinforce the importance of pausing and identifying any new hazards when the scope of a job changes.
- There will be an internal hazard alert sent out

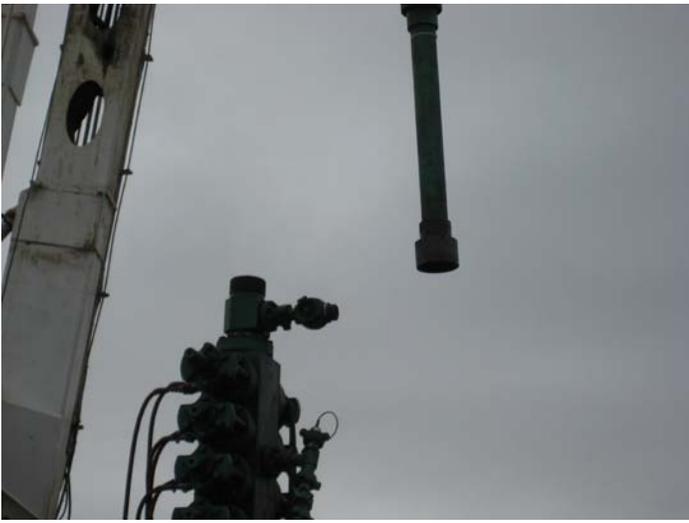
The lubricator assembly sprung free off the top of the BOP stack and sprung backwards, striking the operator in the Genie lift in the face and knocking him down.

Image 2 is the approximate kick of the lubricator stack.

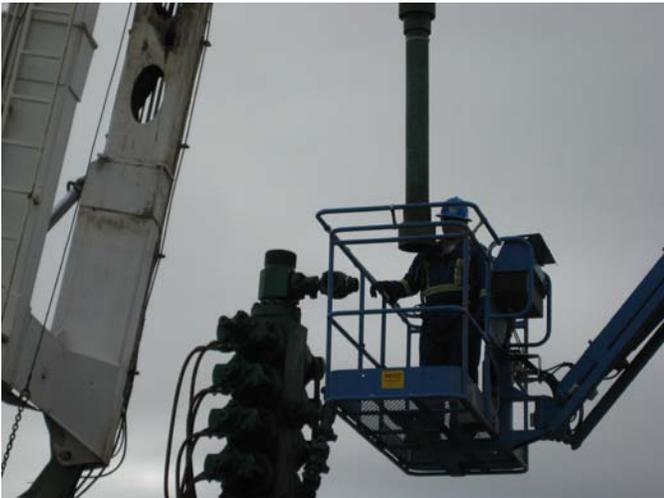
Image 3 is the employee being struck by the lubricator.

The operator underwent an MRI, was diagnosed and underwent surgery to repair a fractured cheekbone and misaligned orbital socket. His recovery time is estimated to be 4 weeks, then a light duty program should be able to be instituted.
