The Safety Association for Canada's
Upstream Oil and Gas Industry

Instrument Tubing Failure Resulting in a Serious Injury

SAFETY ALERT

ISSUE #: 10-2011

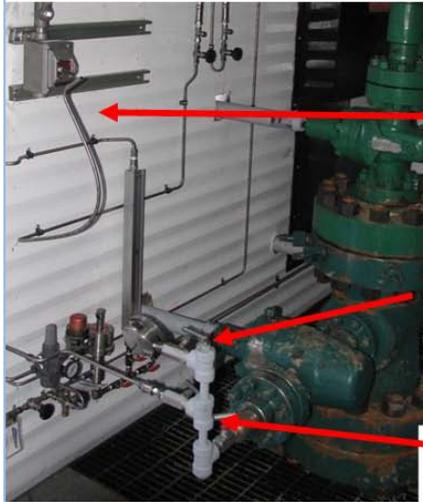
- The tubing was 3/8" .049 wall thickness stainless steel. The fitting is a double ferrule style. All met manufacturer's specs.
- The tubing had been installed into the fitting nut to the correct depth and the ferrules were installed in the correct order.
- The fitting nut had not been tightened as per manufacturer's recommendations (finger tight plus 1 1/4 turns) therefore the ferrules were not "set" into the tubing. When examined post event, the nut was found to be finger tight (3 full turns).
- The installer had 'batch marked' the fittings in his post installation check vs. checking then marking one at a time.
- The well commissioning process had not caught the leaks.
- Fittings under pressure need to be depressured before tightening; this practice may have not always be followed.

Tubing Bent By Release.

Fitting Nut

Casing Assembly

- Leaking tubing fittings under pressure can be extremely dangerous and must be depressurized before being touched.
- Field correcting of tubing installation deficiencies without follow up with the contractor prevents the sharing of findings and the opportunity for the contractor to correct the deficiencies and implement the necessary corrective actions into their procedures.
- Field installed tubing should be hydrostatically or pneumatically tested per ASME B31.3 methods in conjunction with the contractor's QA/QC program.
- Review well commissioning processes to identify tubing installation testing and verification.
- Verify training for the correct installation and operation of fittings.

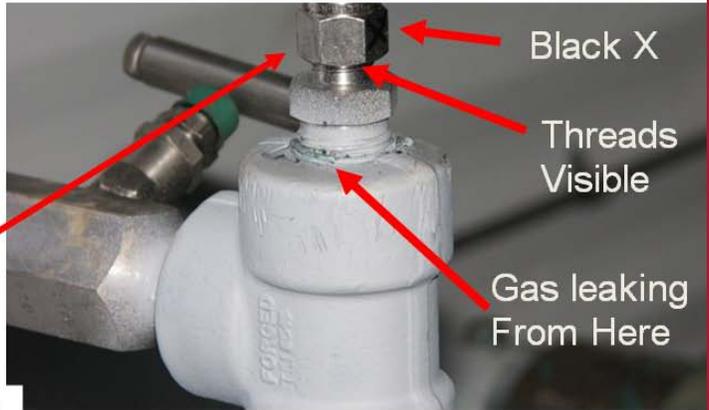
Black X

Threads Visible

Gas leaking From Here
