# Object Falls from Height

**Enform**

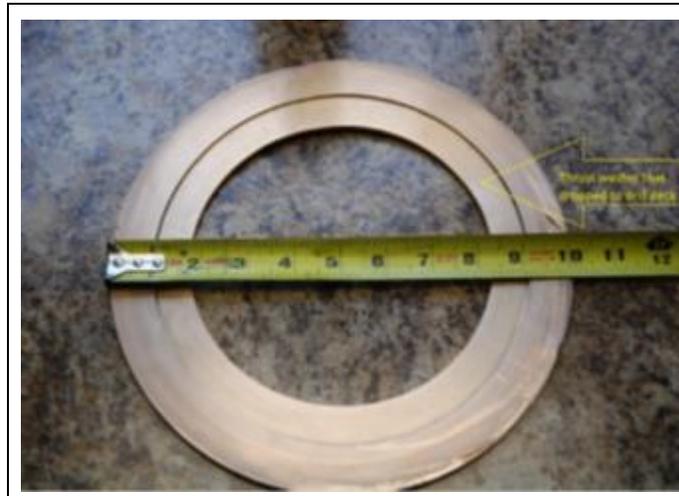
Figure 1

- This incident occurred at a drilling rig during standard drilling operations.
- At the conclusion of a cementing operation, and during tripping and laying down the cementing pipe string, the drilling crew discovered a 25.4 cm diameter, 0.68 Kg brass thrust washer lying on the ground on the rear of the drill floor (Fig. 1).
- The washer had fallen from the inside of the top sheave in the crown assembly of the rig derrick, missing the nearest worker by 2 meters.
- A visual inspection, performed by crew from the ground using a camera with a telephoto lens, identified that the sheave pin (which forms the axle for the sheave) had moved laterally and the sheave was noticeably leaning from its normal, vertical position. (Fig. 2)

- 25.4 cm diameter, 0.68 Kg brass thrust washer

- Installed Nord-Lock Washers and Loctite on all lock plate bolts.
- To ensure bolts are secure prior to each time the derrick is raised, the lock plate bolts shall be torqued to 41 lb-ft. and this procedure will be captured in the corresponding JSA/SOP for completing a pre-raise derrick inspection and in the inspection itself.
- Although the crown inspection that was completed prior to the incident was thorough it was generic stating that “all crown bolts are secured and in good repair”, the inspection document has been updated to specifically identify the need to inspect each locking plate and the corresponding bolts.
- This style of the derrick does not allow access to the crown when it is in the raised position. Rig Managers will be provided with binoculars to inspect the crown assembly, specifically the sheave pins from the ground level during daily walk around inspections.

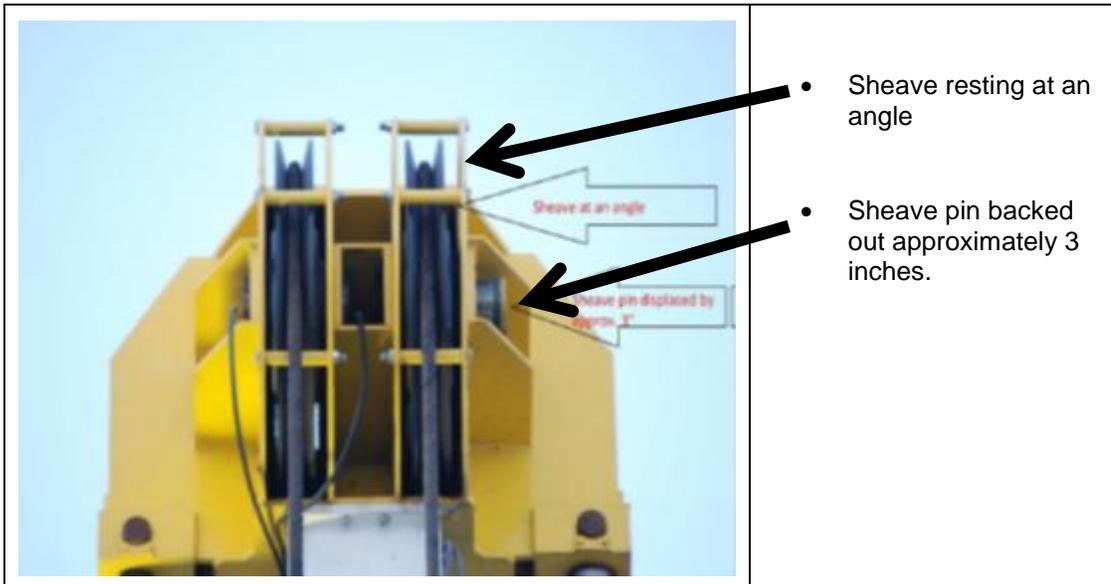
Figure 2

- A crane equipped with a man basket was mobilized so that personnel could access the crown to inspect, render safe, and repair the damage.
- At this time it was observed that the outer sheave locking plate bolts had sheared and the plate itself was seen resting on the edge of the crown assembly.
- These conditions created the potential for a more serious incident, necessitating a suspension of rig operations.

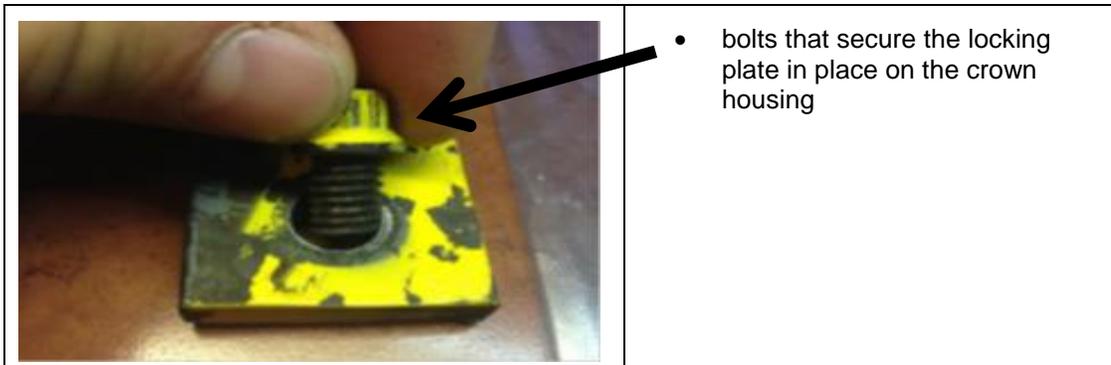
Figure 3

- The bolts that secure the locking plate in place on the crown housing became loose over time. As a result the locking plate was making contact with the sheave pin. This continued movement from the sheave pin onto the locking plates resulted in wear on the locking plate bolts and caused the subsequent failure of the bolts.
- Restricted access to locking plates did not allow workers to clearly identify the backing off of the locking plate bolts.
- A review of product specifications did not indicate the requirement to torque the crown pin keeper plate bolts to a specified range; or to perform inspections on this area of the rig on a prescribed basis.

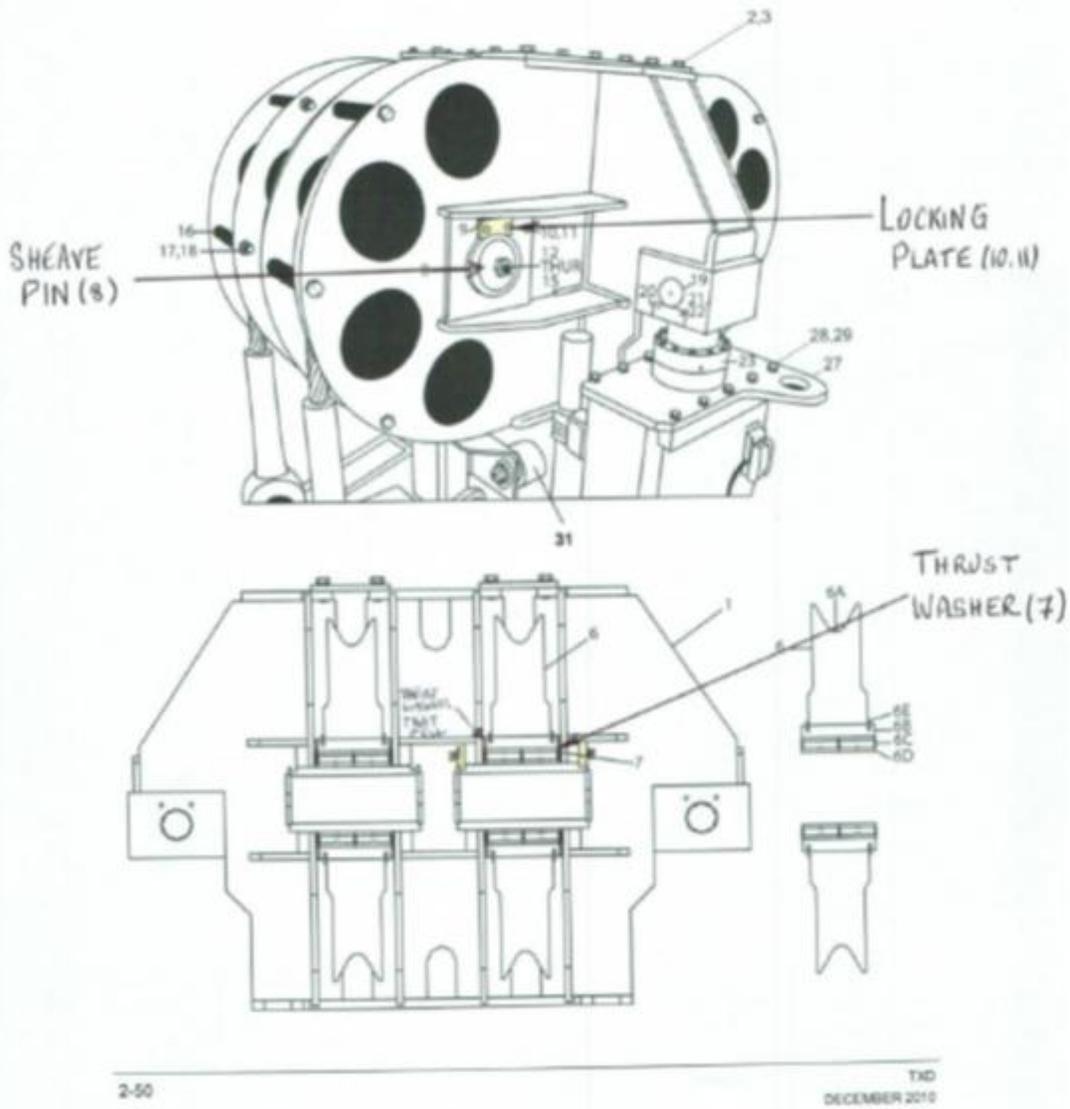
Figure 4

Upper Sheaves  
P135-2804
