Picker Mount Failure

SAFETY ALERT

ISSUE #: 13-2014

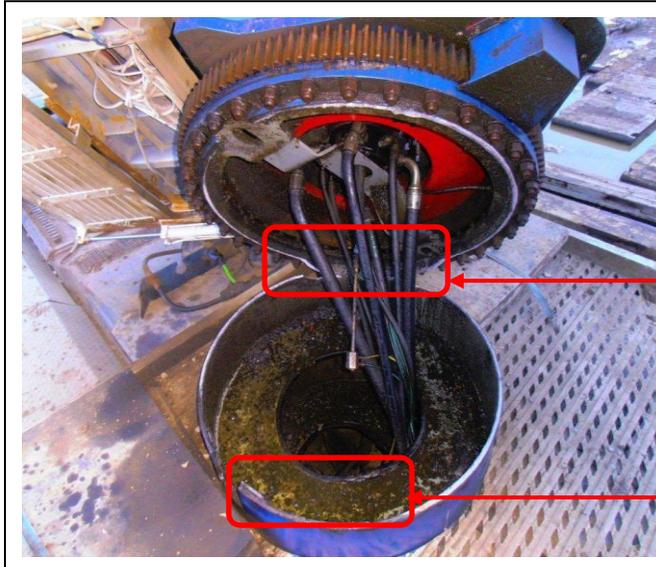
Figure 1

In April 2014 a truck mounted, 40 ton crane (Picker) had arrived on a new drill site location and set up to load out substructure matting. While lifting a sheet of matting, the turret bearing mount cracked and tore off, near the sub structure deck (see Fig. 1) of the picker truck causing the crane to collapse, which also bent the boom and damaged the matting (see Fig. 2). The crane cab did not completely overturn, as there was still support steel attached to the deck of the truck at the point where the crane bent over.

Turret Bearing Mount

Note: Incomplete separation of turret mount

Note: Rust in part of crack indicates pre-existing condition

All causes, immediate/system/root, lead back to the pre-existing crack not being noticed on the sub structure near where it attaches to the turret bearing mount plate. During the investigation it became apparent that this is an area that requires more attention than had been given during different levels of inspections. The area where the crack originated is only 6 inches up from the deck and very difficult to inspect on a pre-lift visual check. In addition, three different inspection companies reported this is a difficult area to Non Destructive Test (NDT) during the annual inspection. Other incidents with other operators were noted where this problem had been identified, but not adequately communicated to Industry.

- Challenge the inspectors when doing the annual inspection to complete a NDT on this area of the picker to identify any pre-existing issues.
- Thoroughly inspect the area between the bolt plate and the deck during pre-lift visual inspections.
- This incident will be shared with the Industry through Enform to be sure all are aware of this event and the importance of thorough pre-lift inspections.
- A management of change policy will be developed to initiate more research when new equipment is introduced to the work place to identify special concerns and mitigation procedures up front.

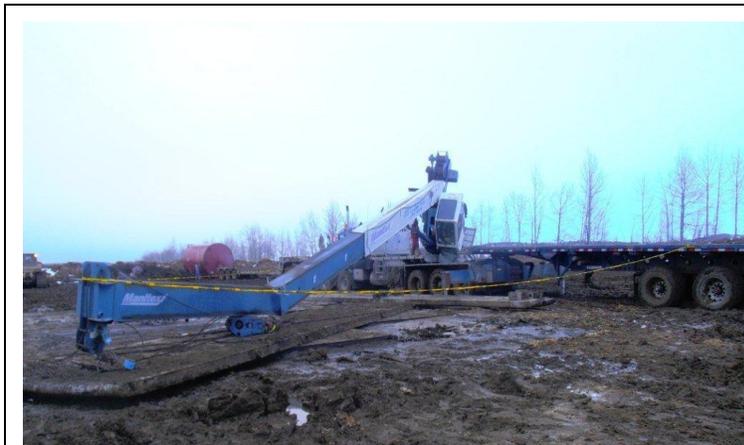
Figure 2

Crane Collapse

Largely as a result of the crane remaining attached to the deck and not carrying the operator cab over, the crane operator did not sustain any injuries. Support crew followed the pre-job safety meeting outlined procedures, and were stationed well away from the lift zone, so no associated injuries were recorded.
