SAFETY ALERT - #04-2009
RUPTURE OF HIGH-GRADE NITRILE HOSE
RELEASE DATE: APRIL 14, 2009

Function: All Oil and Gas Operations	Incident Date: May 26, 2007
Location: Offshore	Location Detail: Floating production storage unit
Incident Type: Equipment Failure	Country and Region: Canada, Offshore Newfoundland

A 4" diameter N2581 Petralflex high-grade nitrile hose ruptured during normal operation.

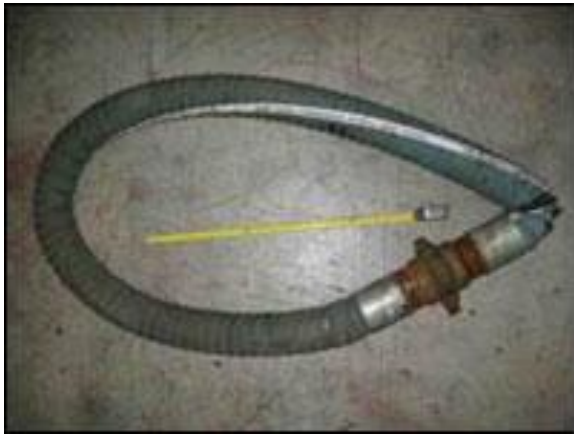
Figure 1

The internal diameter cannot be any less than 20 inches so as not to be below its specified minimum bend radius during transportation or use.

The maximum measure of flexibility for a given hose construction is typically defined by a minimum bend radius which is specified by the manufacturer. To maintain the integrity of a hose, this minimum bend radius cannot be exceeded when storing, transporting or using the hose. The appropriate method for storing hose depends to a great extent on its size (diameter and length), the quantity to be stored, and the way in which it is packaged. Hoses should not be piled or stacked in a way creates distortions on the lengths stored at the bottom.

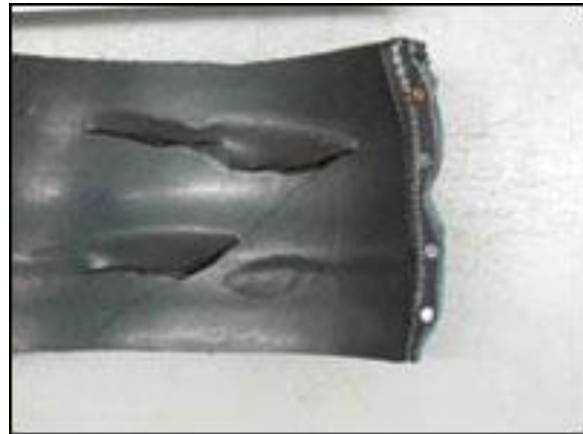
Figure 2

A detailed failure investigation confirmed that the rupture was caused by excessive flexing of the hose exceeding the specified minimum bend radius recommended by the manufacturer. Sources of excessive flexing identified include:

1. The hose configuration currently utilized to transport the hoses and the use of relatively tight "pigtailed" during job site operation. For transportation purposes the hose ends were joined, which imposed a bend radius below the minimum specified by the manufacturer. This excessive flexing of the hose caused minor delaminating and tearing of the inner nitrile tube layer of the hose. (See Figure 2)
2. Prior to the failure, the centrifugal pump utilized in the system loop was replaced by a double diaphragm positive displacement pump. The varying suction pressure associated with the use of the positive displacement pump units may have caused any delaminations and tears to grow.

This photograph shows the two circumferential tears in the inner nitrile layer and circumferential compression wrinkles.
