Refridge Flash Fire

Safety Alert

Issue #: 1-2016

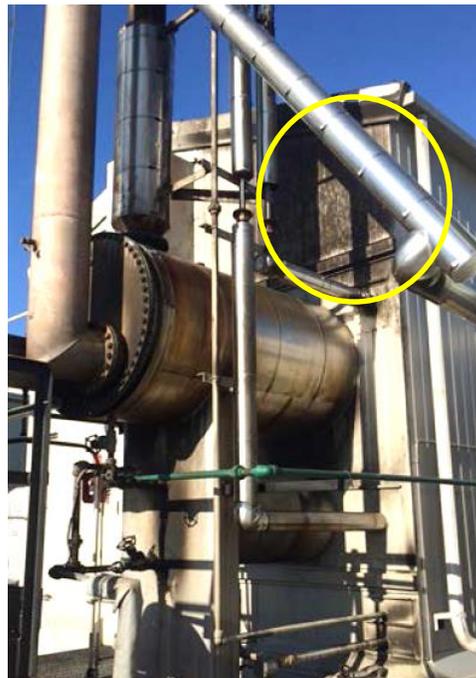
An operator recording equipment readings (logging) at the refrigeration (refridge) building observed scorch marks on the exterior of the building and glycol/steam venting out of a pressure release vent on the still column. The scorch marks were located above the reboiler unit as well as on the reboiler unit itself and the associated piping and insulation.

Scorched Exterior of Refridge Building

A buildup of condensate in the system.

- The reboiler is designed to flash off water and any associated hydrocarbons, including benzene, by heating the glycol to approximately 120°C.
- If hydrocarbons are present at a sufficient volume in the glycol, a hydrocarbon-glycol foam can form on the surface of the glycol within the glycol accumulator.
- In this case the buildup was such that it triggered the pressure release vent, releasing hydrocarbon vapours that subsequently ignited.
- The precise cause of ignition is unknown, but may have been the hot reboiler exhaust stack.

- Failure to maintain a glycol/condensate interface in the Low Temperature Separator. Personnel felt that glycol skimming was not required because the location no longer produced condensate.
- Operators were not trained in maintaining the interface in the Low Temperature Separator.
- The pressure release vent on the still column was undersized.

- The pressure release vent was replaced with a properly fit for purpose design.
- Operators received additional training in the maintenance of glycol refrigeration systems.
- Operators will skim the glycol accumulator on a regular basis. This task may have the potential for operator hydrocarbon exposure (namely benzene), therefore an exposure assessment was recommended.
- Sampling of the gas and glycol will be conducted on a regular basis.

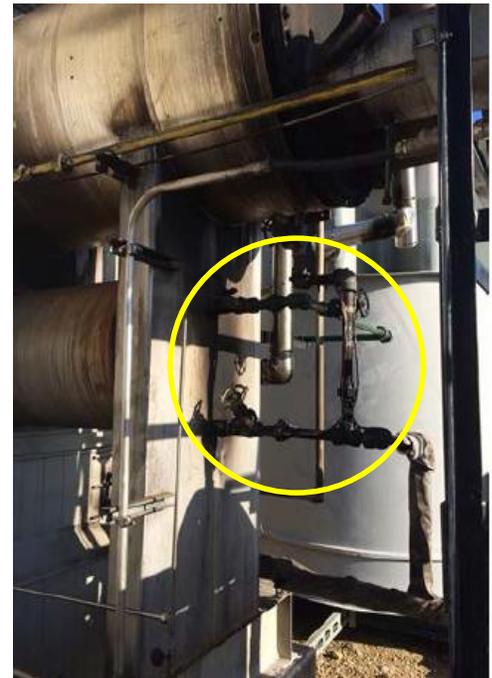
Scorched Piping/Insulation Under Reboiler
