Rod Wheel Injures Worker

SAFETY ALERT

ISSUE #: 08-2014

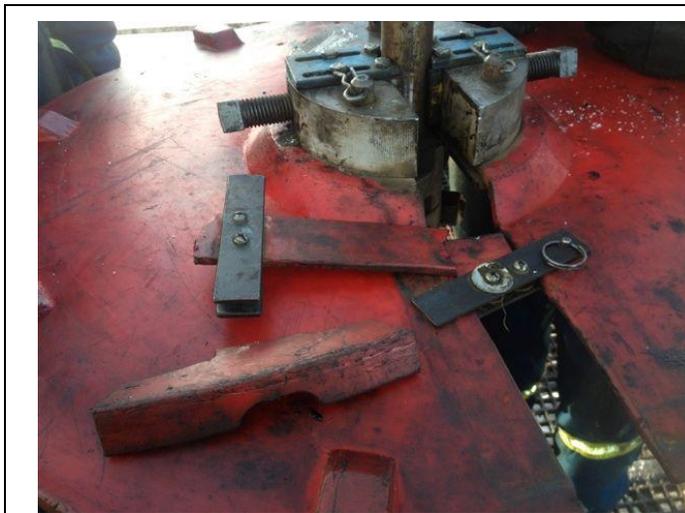
A rig crew was attempting to manually latch a running tool onto the top of a tubing liner pump downhole. A rod wheel was installed onto the rod string. Workers on the rig floor held 10 to 15 turns of torque into the rod string with the wheel as the rod string was lifted. The running tool detached from the lock assembly causing the workers to lose their grip on the rod wheel. The release of torque caused the rod wheel to backspin uncontrolled. While spinning, the gate piece of the rod wheel broke away from the main body of the wheel, striking a worker in the face and resulting in major facial injuries.

The gate piece of the rod wheel broke away, striking a worker.

- Defective tools: The rod wheel is made of plastic and if the rod wheel backspins from torque, the gate in the wheel is subject to failure.
- Improper procedures: There is no safe method of placing torque into a rod string using a rod wheel. If control of the wheel is lost, the resulting backspin places workers at risk from disintegration of the gate.

- There are no manufacturer operating specifications for the rod wheel to identify torque limitations or maximum number of turns on a rod string before it becomes a hazard.
- Use of a rod wheel relies on workers manually holding a device with torque applied and, if they lose control of the wheel and it fails, there is no way to protect the workers.
- Recommended engineering control: The use of jaw-type rod tong dies coupled with a backup arm to rotate the rod string removes the hazard to workers.

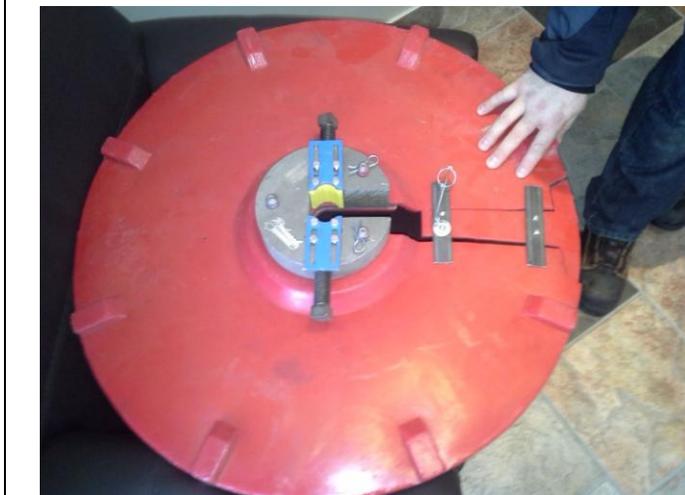
A new rod wheel
