SAFETY ALERT - #02 - 2010

SLIPS CATCH ON SERVICE RIG FLOOR INJURING WORKER

Function: Well Completions and Servicing	Release date: February 18, 2010
Incident Type: Hazard Alert	Country and Region: Western Canada

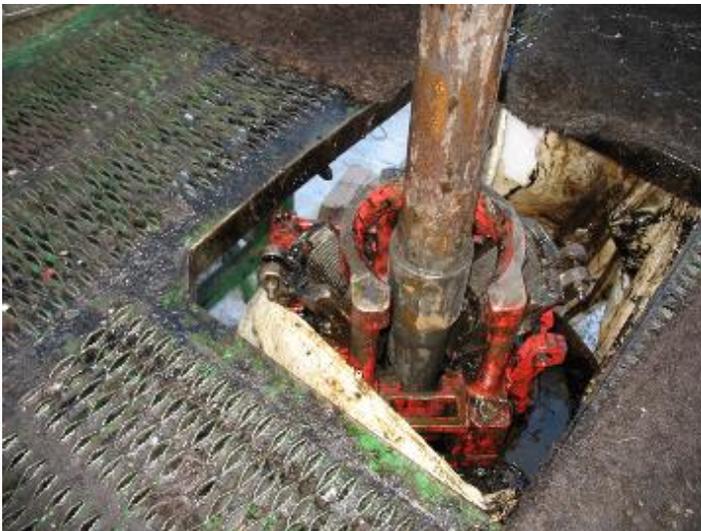
A service rig crew was pulling 114.3 mm (4 ½ inches) tubing from a well. The operator was running in fourth gear when the clutch was disengaged. The tubing was moving upwards on its own momentum as the brakes had not been applied yet. At this point in the operations, the tubing collar snagged the **square** shoulder of the stripper plate on the bottom of the slips. This caused the slips to flip up and the control arm of the slips to bind under the edge of the rig floor.

This impact resulted in the rig floor lifting by approximately 0.2 meters (8 inches) where the control arm was binding. The back of the rig floor was heaved up by over 0.5 meter launching the floorhand into the tongs. The worker sustained a fractured clavicle, when the tongs struck his left shoulder area. He also broke a rib, when he fell onto the back floor railing.

Photo 1: Position of Slips Under Service Rig Floor

1. Ensure the slips are installed above the height of the rig floor.

Comment: There are times when it is not possible to position the slips above the rig floor. In these cases, it is advised that a more detailed hazard assessment be conducted and the appropriate control measures implemented.

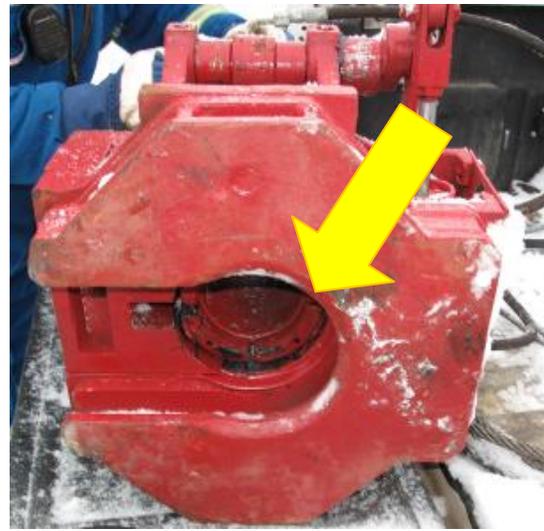
Photo 2: Beveled Edge on Stripper Plate

In this case, the design flaw on the bottom of the stripper plate with square edges allowed the tubing collar to catch and resulted in the slips being lifted up. With the slips in such close proximity to the rig floor, if they catch, the incident occurs before the driller has time to react and the rig floor is lifted violently thus propelling the workers into equipment as occurred in our incident. It is worth noting that there was a fatality and a serious injury in the U.S. when the slips caught on the rig floor.

2. Ensure the stripper plate has the same design as the bottom of the slips.

Comment: The original equipment manufacturers (OEM) design is to bevel off the bottom of the slips to prevent snagging. Using the same design for the stripper plate installed on the slips would mirror the manufacturer's design.
