Snatch block sheave fall

Safety alert

Issue #: 10-2015

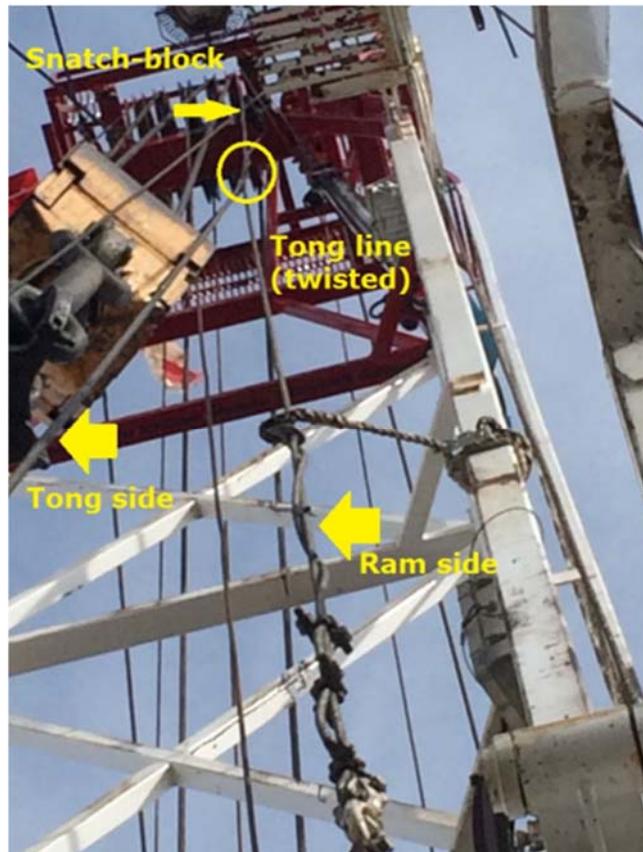
Re-enactment photo

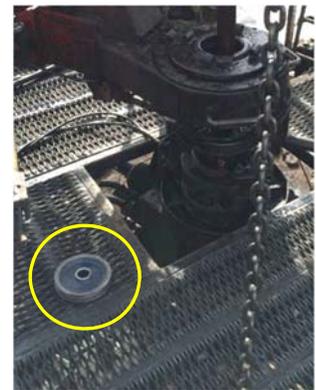
While making tubing connection on a service rig the floorhand noticed the tongs were jerking. He looked up to the crown of the rig and noticed that the snatch block lines were twisted. Work was stopped, the lines untwisted and an inspection of the snatch block was conducted with no external damage noted. Work proceeded until on the following day, when pulling out of the hole, the tongs dropped approximately 1 foot. The floorhand heard a loud bang and the sheave from the snatch block landed approximately 3-4 feet away from his standing position on the rig floor. An inspection of the snatch block identified damage and evidence of side loading. Earlier the rig manager was provided with the 1-tonne snatch block and instructed to use it. The snatch block was rated for one tonne, where an 8-tonne had been used previously based on the calculated loads.

Sheave that fell to rig floor

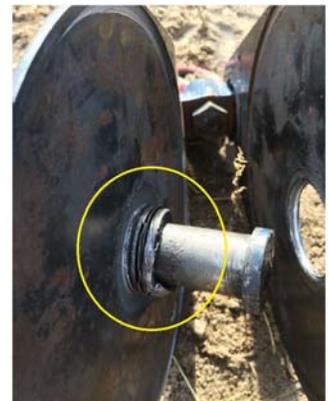
Damage to snatch block, evidence of side loading

There was excessive load on the snatch block.

- Communication between the rig manager and the field superintendent was inadequate.
- The rig manager did not conduct load calculations.
- Established change processes were not managed properly.
- The self-study training on rigging and slinging the rig manager had completed was not adequate, resulting in a lack of competence.

- Load calculations must be performed and documented prior to installing rigging and hoisting equipment.
- Established change processes must be managed diligently.
- Your supervisor should be contacted immediately if you are unsure of manufacturer's specifications.
- It is everyone's responsibility to ask questions and refuse work that is unsafe.
