# Snubbing Unit Parted Pipe / Jack Relief Failure

## SAFETY ALERT

ISSUE #: 14-2014

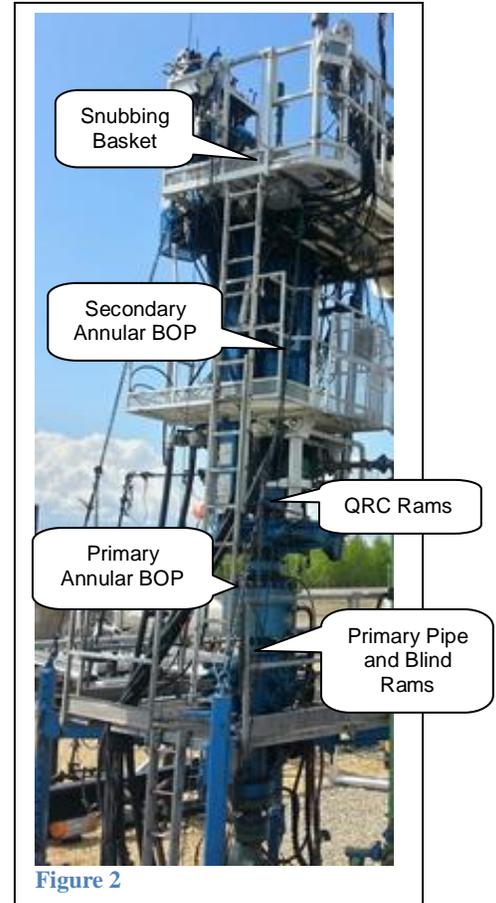
Figure 2

After pulling approximately 200 metres (19 joints) of tubing out of the hole, the operator encountered a sudden release of wellbore pressure. The operator secured the control panel and both workers exited the upper snubbing basket. The operator and site supervisor then regained well control with the primary pipe rams. A preliminary inspection revealed that the joint of tubing sitting in the traveling heavy slips had parted above the upset (see Figure 2). The remaining pipe was closed in the primary rams.

The conclusion of the investigation was that the operator had miscounted hydraulic jack strokes and pulled a coupling into the lower stripping QRC ram. At impact the force of the hydraulic jack parted the tubing string. The hydraulic jack reliefs are designed to relieve before the maximum tubing tensile strength is reached (in this case, 31.9 deca-newtons (DAN)) and this should have been sufficient to prevent the tubing parting. The jack reliefs were confirmed to be set at 28.5 DAN. It was discovered through testing that the relief setting was exceeded due to the momentum of the snubbing jack and hydraulic system inefficiencies (up to 35 DAN spikes).

- Given the severity of this incident and the potential for a more serious outcome, all operating companies that provide snubbing services are strongly encouraged to complete their own testing to determine if this hazard exists on their equipment.
- If this hazard is present, the manufacturer of the snubbing unit should be contacted and a plan developed to rectify the issue. The control for this hazard will vary depending on the design and configuration of the snubbing jack and its hydraulic makeup.
- All jack reliefs should be set to a maximum of 80% of the tubing tensile strength. If there is a need to exceed this setting, such action should first be approved by the operating company's management.

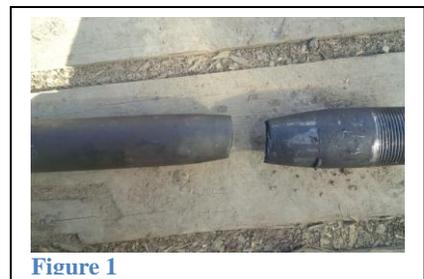
Figure 1

The incident occurred on a hydraulic snubbing unit, which is a unit designed to trip tubular and downhole assemblies into and out of wellbores under pressure at surface (see Figure 1). A snubbing crew on a gas well was performing work which consisted of snubbing a tubing string out of the hole under pressure.
