# Top Drive Counter Weight Falls From Derrick

## SAFETY ALERT

ISSUE #: 01-2015

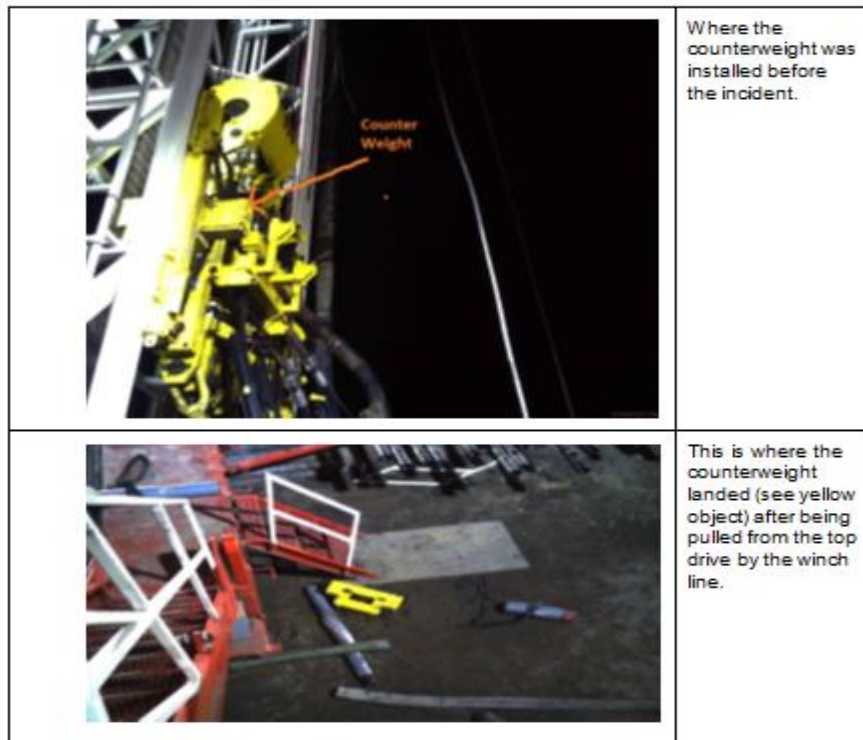
The crew was preparing to lay the mud motor out the V-door. The hydraulic bails were extended and the driller began lowering the top drive. The motor hand and floor hand pushed and guided the motor out of the V-door as it was lowered. The winch snapped, violently striking the motor hand in the right shoulder; at the same time, a large piece of steel off the top drive flew past the workers and landed on the ground beside the substructure.

- The crew failed to notice that the winch line was caught on the top drive when it was parked
- The top drive was lowered to lay out the mud motor, and the winch line was caught behind the counterweight
- The service platform had been removed from the top drive at an earlier date. The platform is not designed to be a guard; however it would have prevented the winch from snagging the counterweight
- The top drive counterweight did not have secondary securement

- Clearly identify the hazard of having the winch line snagged on anything in the derrick
- Conduct regular inspections of top drives and all other overhead equipment, and pay particular attention to secondary securement
- Consider designing/installing secondary securement devices on rigs with top drives, along with a new-style guard that prevents the winch line from coming into contact with the top drive
