Tractor-Trailer Uncoupling Results in Accident

SAFETY ALERT

ISSUE #: 09-2014

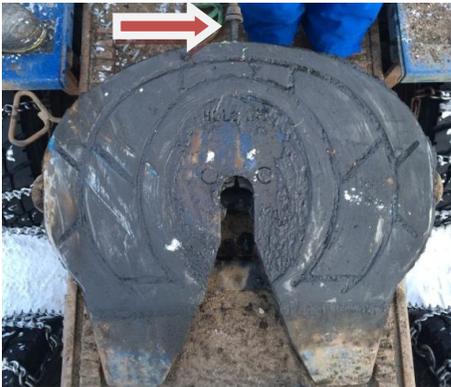
<p>Fifth wheel pin/washer out of locking position</p>

- Physical checks alone are not adequate to determine a solid coupling, particularly with winter conditions and a fully loaded trailer. Before initiating a trip, as part of the pre-trip inspection, confirm that:
 - the pin/washer is flush against the fifth wheel ensuring a secure lock,
 - there is no gap between the fifth wheel & trailer,
 - locks are completely closed around kingpin, and
 - a pull test is performed.
- Fifth wheel and coupling mechanisms must be fully cleaned and cleared of any snow, ice, or debris before trailer engagement.

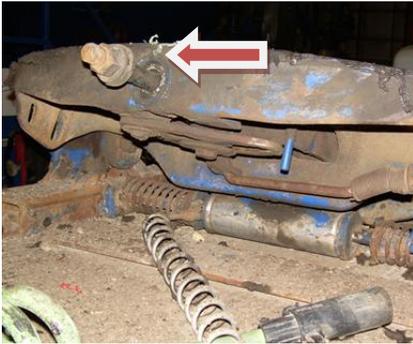
<p>Pin/washer is not sitting flush against fifth wheel</p> <p>To ensure a secure lock, the pin/washer must be flush with the 5th wheel.</p>

- Failure to check/monitor/observe: Driver conducted tug test & brake checks, however this was not adequate. The employee failed to verify that the pin/washer was flush against the fifth wheel, ensuring a secure lock.
- Failure to identify hazard/risk: Driver failed to identify that cold conditions (-35°C) could affect the functioning of the fifth wheel. Frozen grease and snow build up under the fifth wheel contributed to decreased function of the fifth wheel locking mechanism.
- Lack of knowledge/situational awareness: Units were brought up on a winter road, causing significant snow and ice buildup around the fifth wheel plate which made the grease stiffer than normal. The driver was not aware that partially locked jaws (i.e. yolk not fully engaged) could still result in a successful tug test.

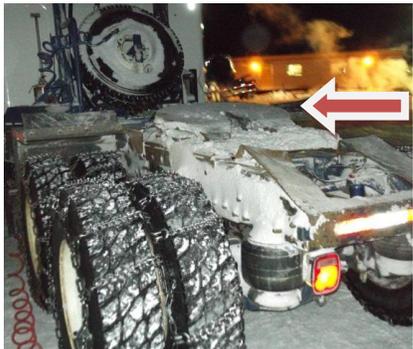
<p>Snow and ice not cleaned properly before trailer coupling</p>

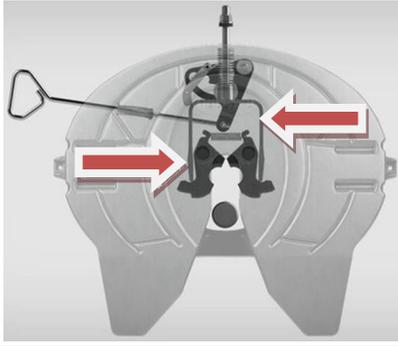
Yolk and jaw did not function properly due to snow and ice packing into the coupling mechanism
