SAFETY ALERT - #22 -2009
WELLHEAD PIPING: FREEZING HAZARD
RELEASE DATE: NOVEMBER 13, 2009

Function: Production Operations	Date: October & February 2009
Incident Type: Hazard Alert	Country and Region: Western Canada

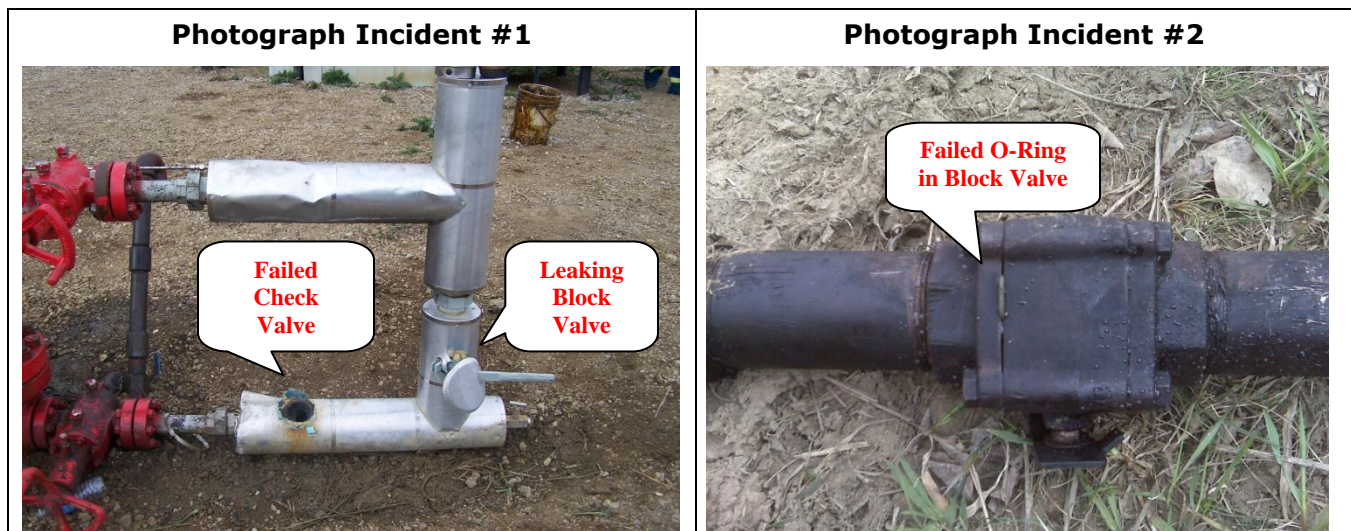
While pressure testing wellhead piping prior to re-starting a shut-in well, the cap on the check valve on the casing piping blew out. The crew began by testing the tubing side piping. The tubing valve was leaking resulting in the casing side piping also being pressurized. At this point the threaded check valve cap blew out (See Photo #1 below). Two nearby workers were sprayed with fluids trapped in the piping. Neither worker was injured; however this incident had the potential to be fatal. A visual inspection after the incident identified that the check valve failed due to internal stresses, which were probably caused by the freezing of water trapped inside the valve body. Water originated from a leaking block on the casing piping. The threads on the check valve cap were stripped / deformed. A formal failure analysis was not completed.

The company received a call from Alberta Forestry who reported that there was oil leaking from a wellhead. The operators drove out to the lease and found the well was still leaking oil out of the casing valve. The valve failure resulted in a 30 m³ spill. A failure analysis confirmed that the valve failed due to internal stresses caused by the freezing of water trapped inside the valve body (See Photo #2 below). In addition to valve failure, the downstream valve flange and connecting nipple were also deformed. The water in the piping is believed to be the result of a wellhead operation that was completed several months prior to the valve failure. The investigation was unable to confirm if the piping was depressurized and if the trapped liquids were drained.

- Highlight potential freezing hazard in future well handover meetings between production operations and well servicing personnel. The need to confirm that all lines have been flushed and properly secured by either the wellsite supervisor or operator prior to leaving a wellsite.

- Reinforce the importance of inspecting equipment closely for valve damage or piping corrosion prior to starting any type of work activity on a shut-in or suspended well. If necessary, cladding and insulation may need to be removed to permit such an inspection.

- Review required procedures and equipment for pressure testing surface piping with a controlled source of pressure. It is not acceptable to pressure test with well fluids. This is especially important when there is any level of H₂S present. Alternatives include using Baker pump and a non-compressible fluid that is not susceptible to freezing (i.e. RV Antifreeze).
