## SAFETY ALERT - #01A - 2010 REVISED

### WORKER CRUSHED WHILE UNLOADING VACUUM TRUCK

<b>Incident Type:</b> Crushed by Equipment	<b>Re-Release Date:</b> February 05, 2010
<b>Operation:</b> Trucking	<b>Country of Origin:</b> Canada

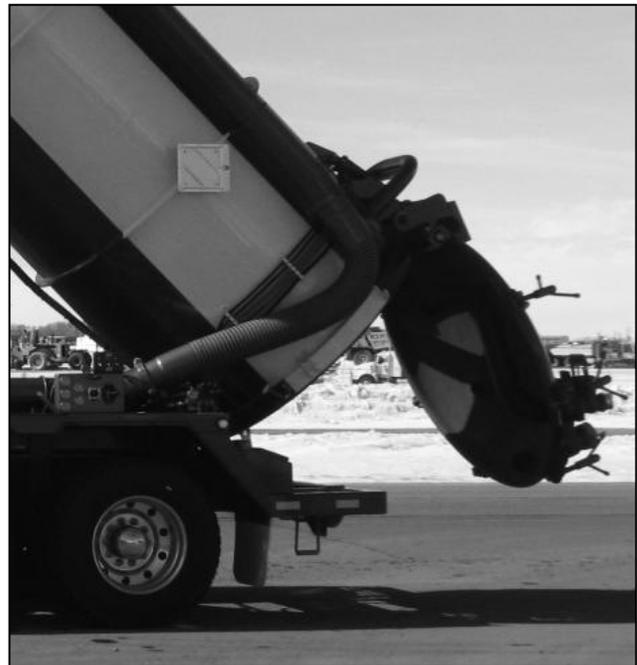
While dumping of the contents of a vacuum truck unit, a swamper was killed when he was caught in the closing vacuum truck tank door.

- The workers had cleaned the tank and had both stepped down from the rear tank access platforms (also known as, beavertails).
- The operator walked around to the driver's side of the truck to access the hydraulic control levers located directly behind the cab of the truck.
- Unknown to the truck operator, the swamper had climbed back up onto the right, rear beavertail and became caught in the swing radius of the rear tank door, as it was closing.

Photograph of the rear door configuration of a typical vacuum truck. Note crush point.

1. The bank of four control levers for the vacuum tank operation were changed;
  - Two control levers have been routed to other locations. The removal of these levers may allow for additional room between the remaining control levers to minimize an inadvertent activation due to their proximity; and
  - The control lever that operates the rear tank door was moved to the rear of the vacuum truck, which allows the operator to maintain a clear line of sight of the door during opening and closing operations.

2. Flow restrictors have been installed on the hydraulic lines to the cylinder for the opening and closing of the rear tank door. This alteration slows down and controls the door's rate of travel;
3. Hydraulic controls have been tagged with permanent markings to provide clearer identification of the function of the control; and,
4. Signs warning of the hazardous pinch point have been installed on both sides of the rear of the vacuum tank.
