SAFETY ALERT - #19 -2009

WORKERS INJURED BY EXPLOSIONS DURING TANK MAINTENANCE

RELEASE DATE: OCTOBER 15, 2009

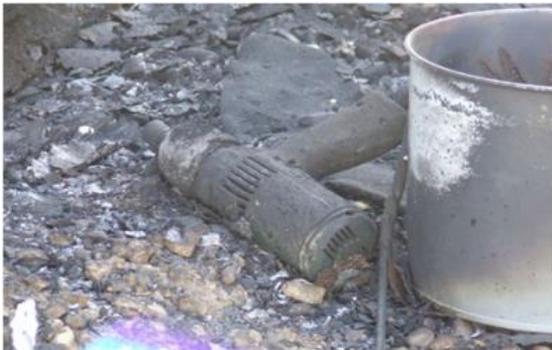
Incident #1: Flash Fire (750 bbl. production tank). 2 workers injured, tank damaged.

Electric Impact wrench used to remove nuts

- Inadequate Supervision: Roles and responsibilities specific to the Hot Work Code of Practice were not clearly defined. (i.e. hazard management, work plans and practices, equipment)
- Failure to Control Hazards: While the potential for an explosive atmosphere was identified during the hazard assessment, no measures were taken to control the hazards.
- Improper Tools: The use of electrical hand tools in an explosive atmosphere.

- Discuss with the field operations staff which tools are acceptable when completing hot work activities. Also, review the Class 1, Zones 0 & 1 sections of the electrical code with the field operations staff and discuss how to confirm if equipment is intrinsically safe.

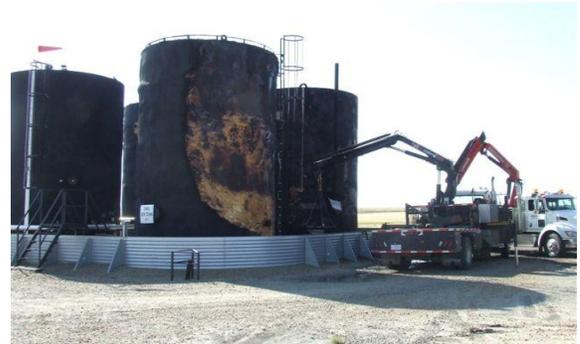
Damaged production tank

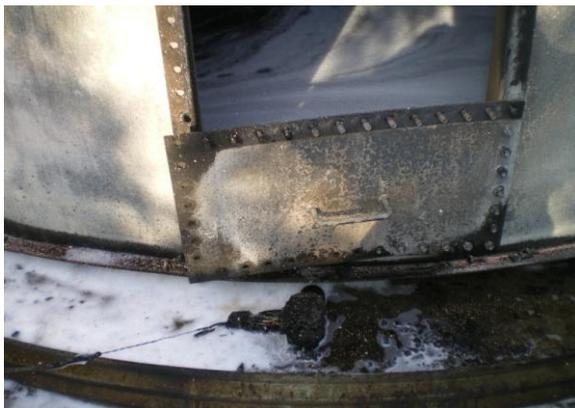
Incident #2: Explosion (1000 bbl. sales oil tank). Worker injured, tank destroyed

View of manway where explosion / fire occurred

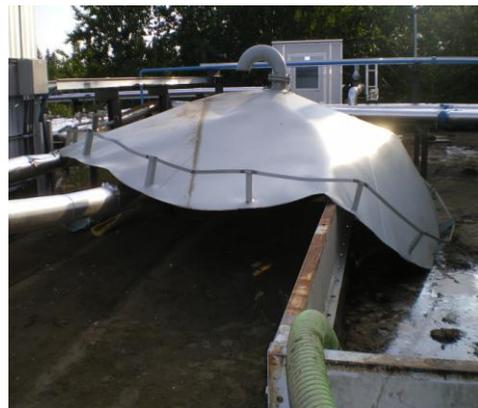
Production tank roof after explosion
