Worker's Hand Crushed in Iron Roughneck

SAFETY ALERT

ISSUE #: 18-2014

Enform

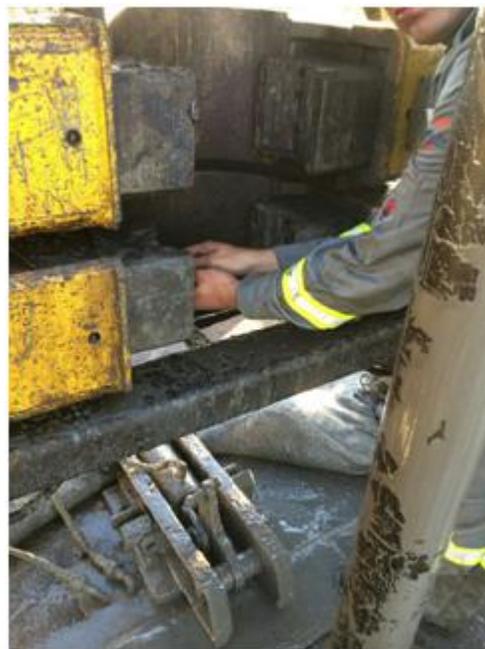
- When engaged, the Iron Roughneck closed and crushed the Floorhand's hand against the Allen wrench he was holding, crushing his middle finger.

Figure 1
Lower Die Block Changeout

- Floorhand hand position
- Use of Allen wrench tool
- Setback of Iron Roughneck from pipe

The primary cause of this incident was the failure to follow standard lock out procedures when working on equipment, including the isolation and physical lock out of the equipment under inspection or repair.

A contributing cause includes the failure of the Driller, who was operating the equipment, to visually confirm that no one was in the field of operation of the Iron Roughneck prior to its being engaged.

Finally, the use of the Iron Roughneck for the purpose of releasing Top Drive pressure is not a standard, documented and approved procedure.

- Before beginning any task ensure that any hazardous energy is isolated, flagged and locked out and key(s) are kept with anyone involved in the task.
- Prior to any task do a basic risk assessment and use your obligation to refuse unsafe work if needed.

- Before operating a control ensure that no one is in the field of operation of the equipment involved.
- During job safety reviews ensure all personnel involved understand the hazards and what needs to be done to mitigate them.

- Evaluate and either document or change unofficial procedures (such as the use of Iron Roughneck to release top drive pressure) including a detailed safety case for each.
