Yoke Failure on Snubbing Unit

SAFETY ALERT

ISSUE #: 15-2011

Release Date: July 22, 2011
Incidence Type: High Potential
Equipment Failure
Country and Region: Western Canada

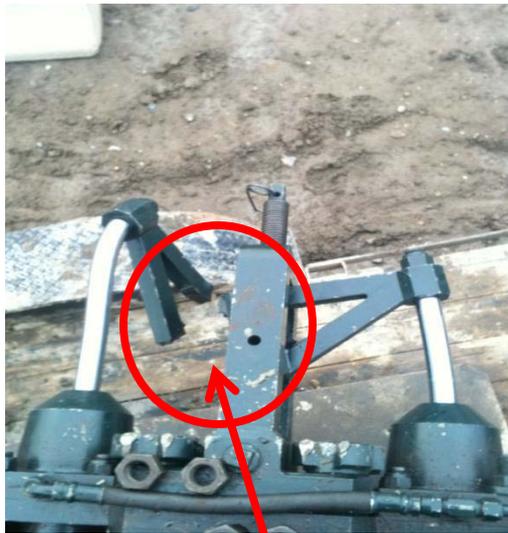
It was then noticed that the lower stripping QRC rams had malfunctioned and did not close properly due to a failure in the operating yoke of the QRC stripping ram breaking on the left side, making it impossible to apply the correct closing pressure to the QRC stripping pipe ram to achieve a seal on the tubing.

- The immediate cause of the incident was the failure of the operating yoke on the QRC.
- The original purchaser of the Rams had requested the manufacturer to modify the original equipment design to improve overall ease of handling, rigging in and rigging out of the BOP.
- The underlying causes of the failure included a faulty design from the manufacturer that did not account for the conditions the QRC was being used.
- A full management of change review was not conducted prior to the changes made to the equipment and assumptions were made about the strength and durability of the operating yoke and QRC.

- The snubbing company has 6 sets of the faulty QRCs and all were upgraded with new, heavier yokes. The yokes that were removed from service were sent for Non-Destructive Testing (NDT) and it was discovered that they were ALL cracked in the same spot.

Broken Yoke

- The manufacturer has been instructed to contact all customers who purchased the QRC's to inform them of the design flaw and remove all smaller faulty design yokes from service pending an engineering analysis on the new design.

- Snubbing operators are advised to add a visual inspection of BOP components to the supervisor's daily checklist.
- Snubbing operators are advised to utilize original equipment manufacturer (OEM) or an OEM approved vendor for BOP service and recertification.
