# Point Lisas Energy Association

## Event Learning

EL#

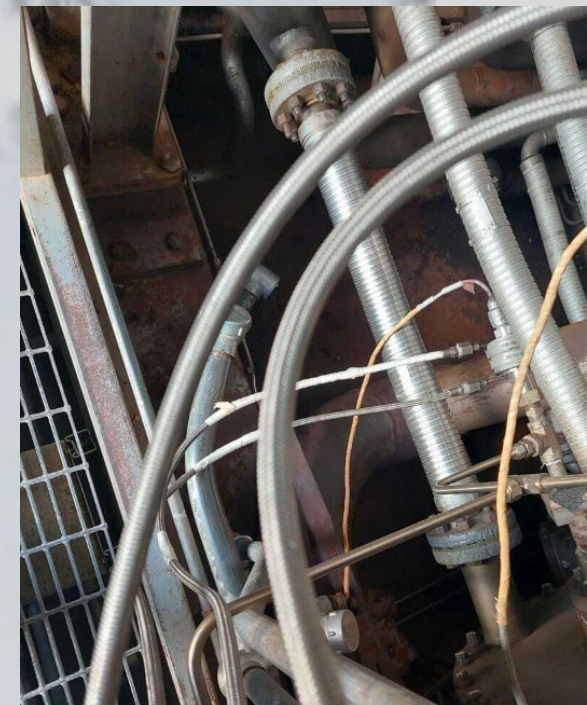
During normalization of the Unit in preparation for start-up activities, the Operator was conducting his final checks inside the Turbine Compartment. His right hand contacted the flexible cooling water line, which was frayed (there were stainless steel threads that were braided), and he obtained a scratch on his wrist (approximately 10 cm long). First-aid treatment was administered.

The valve was situated under the grating and access to the valve was in close proximity to the water cooling lines. The employee had to access the valve by reaching in between the lines. The integrity of braids that protects the hose became worn over time (RC).

1. The frayed wires will be replaced.
2. The employee was not wearing gloves.
3. The SOP was insufficient – it did not cover hazards and risks of using PPE.
4. HAND PROTECTION Campaign to remind employees about types of hazards; required gloves for the different tasks.
