December 2004

Bhopal—A Tragic Event

Union Carbide Bhopal Plant

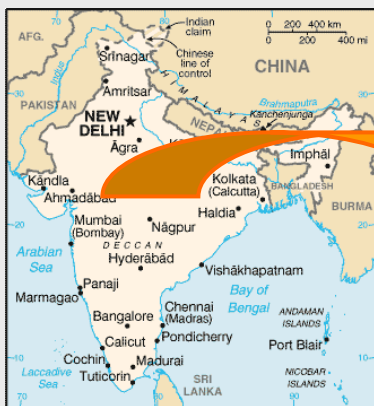
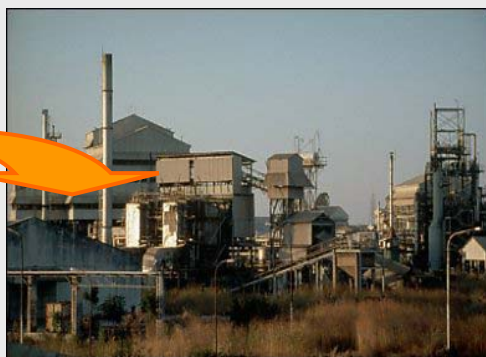
It was just after midnight, December 3, 1984 in Bhopal, India. A succession of events occurred in the Union Carbide India Limited facility that led to the release of ~40 metric tons of methyl isocyanate (MIC) gas. The consequences were tragic: according to the Indian government, more than 3800 people died shortly after the release and thousands were injured.

- ? The basic cause has been agreed upon by most experts who investigated this event: a significant quantity of water entered the MIC storage tank. Water reacted with MIC, temperature and pressure rose and several safety systems could not deal with the event. Eventually, the vessel's relief device lifted, releasing MIC vapor.
- ? 20 years later, the exact water source remains controversial. However, it is clear that installed safety systems did NOT prevent a large release of toxic gas.

- ☞ Understand the reactivity hazards of all materials in your process. Read the reactivity section of your MSDS's, fully understand all reactivity instructions in your operating procedures and be knowledgeable about why your safety systems (e.g. interlocks, relief devices, scrubbers) are there and how they work.

- ☞ If a material in your area reacts with water: 1) be cautious when washing equipment for maintenance or whenever a water hose is used, and 2) remember that compressed air may contain condensed water – be sure process air is free of water before blowing lines.

- ☞ Understand the emergency procedures you are to take if the temperature or pressure increases quickly in vessels storing hazardous materials, especially those which are reactive.
