10,...9,...8,...7,...”Houston, we have launch!

The Incident....

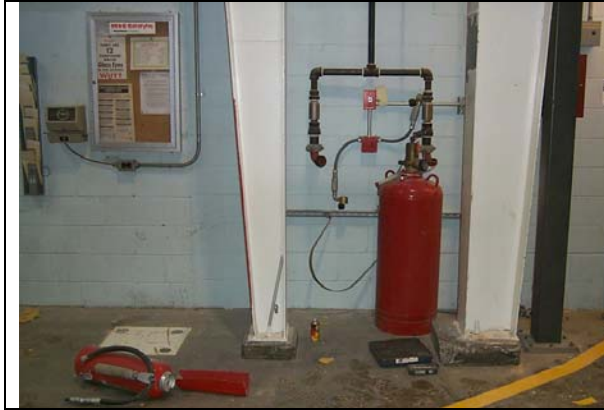
An operator was supposed to remove one of the two FM-200 fire suppression cylinders from service, but things didn't go exactly according to plan. As you can see in the first picture, there's only one of them. During removal of its twin, the cylinder managed to escape and make a clean get away, clear through the ceiling and onto the roof! Look carefully at the second picture and you can identify the need for roof repairs!

Remember this story and the pictures next time you're working with compressed gas cylinders. They have an incredible amount of power - jet power. That's why it's important to practice all those precautions you hear about – keep them chained up, make sure valve covers are in place when moving, follow manufacturer's recommended practices, etc. **And especially, don't allow something to occur which knocks the valve off.** If that happens it could be **“Houston, we have a problem”**.

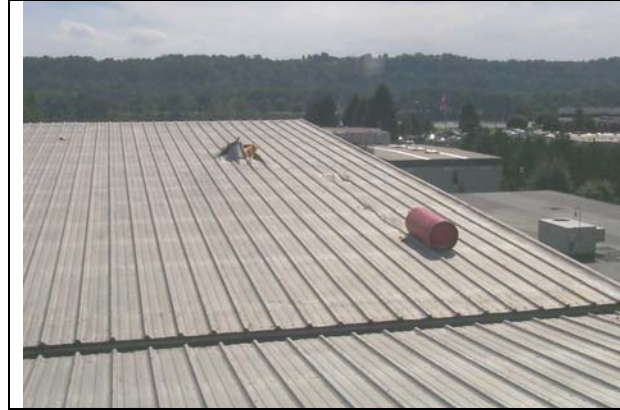
The cylinder that got away

Compressed gas cylinders have an enormous amount of stored energy just waiting to be mishandled, dropped, or vigorously abused. If this energy is released suddenly, they act like a jet engine; not just like - they pretty much are a jet without the combustion process. Exhaust vapor from a broken valve creates a force that moves the jet, or cylinder here, in an opposite direction of the exiting vapor. It was fortunate that this cylinder selected to travel up instead of across the room. The pictures speak for themselves – the forces involved are significant, and major damages to property and people are potential outcomes when this energy is released suddenly.
