A little “nothing” can really be deflating!

VACUUM is a powerful force!

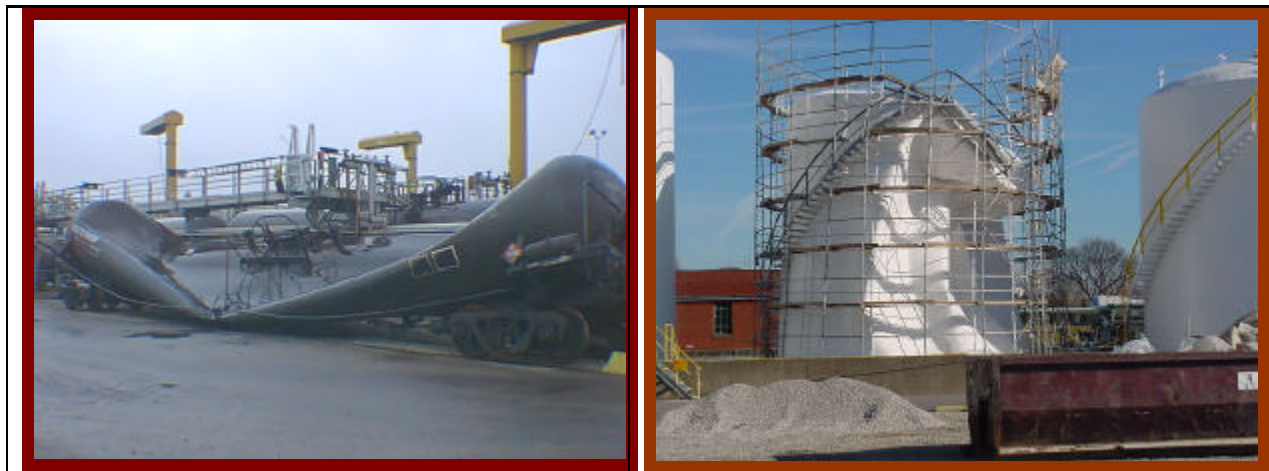
When steam cleaning the interior of a railcar most of the air was displaced. When work was stopped at the end of the day all valves were closed. As the car cooled, the steam condensed, creating a vacuum, causing the railcar to collapse

During painting, a tank's vacuum relief valve was covered with plastic to prevent potential contamination of the contents. When liquid was pumped out the plastic covering prevented air/nitrogen from replacing the liquid volume. A vacuum developed leading to the partial collapse of the tank.

- install a system to provide vacuum relief. As one of the pictures graphically demonstrates, railcars and trucks MAY NOT have this equipment. These devices will allow air to enter the vessel and prevent vacuum formation.
- if installed, vacuum relief devices must be inspected and tested on a regular basis. They are just as critical as pressure relief devices.
- understand which vessels in your department are not rated for full vacuum. These are the vessels vulnerable to vacuum related incidents,
- demonstrate caution whenever liquids are transferred or vapors are condensed because of shutdown, maintenance, cleaning, etc..
- be sure that the addition of air, nitrogen, or other vacuum breaking materials are not impeded.

WHENEVER vacuum relief systems are removed, covered, modified, etc., special precautions are needed to prevent an incident!
