# Airbag Deployment Obstruction

**Safety Alert**

Issue #:10-2016

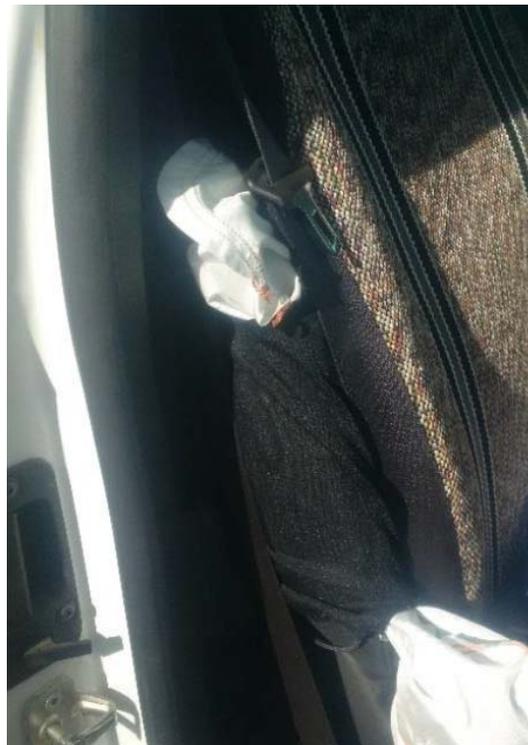
View of partially deployed airbag

An aftermarket seat cover obstructed the deployment of the airbag. In this case, the seat covers were installed in reverse: the driver's seat cover was installed on the passenger side and the passenger's seat cover was installed on the driver side. This placed the hook and loop closure opening on the wrong side of the seat, preventing the airbag from properly deploying.

- Drivers were required to inspect their seat covers for proper installation and implement any corrective actions

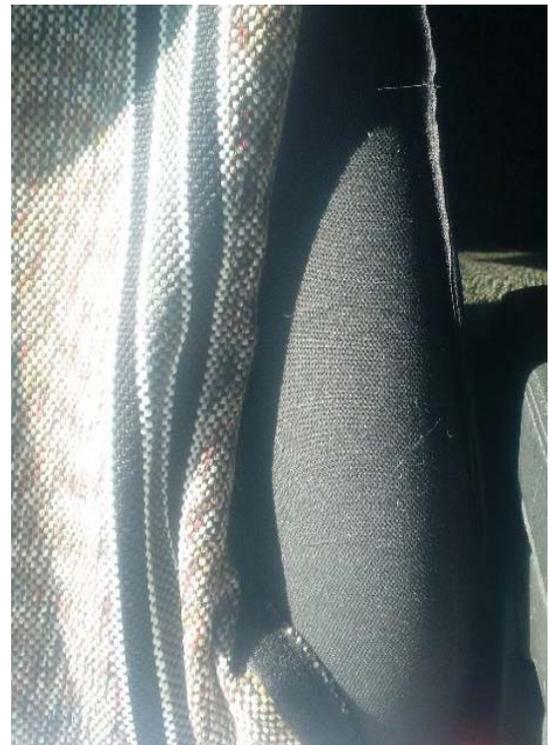
View of hook and loop closure opening on seat cover
