SAFETY ALERT - #14-2009

BALL VALVE IN RELIEF LINE OVER PRESSURED

RELEASE DATE: JUNE 1, 2009

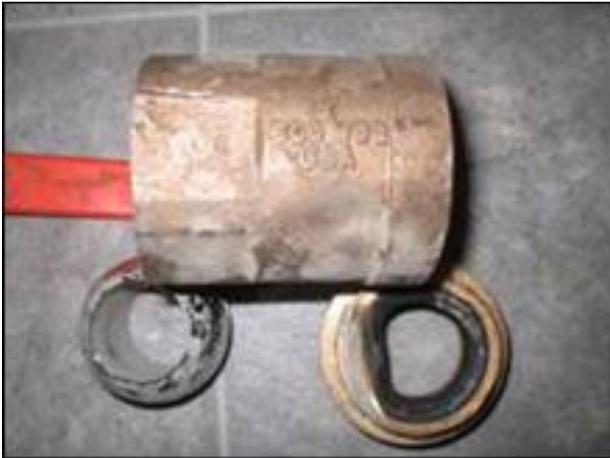
1. **Equipment Pressure Ratings:** All the components of pressure piping system did not meet the maximum pressure rating. In this case, the ball valve that failed was rated for 1725 kPa (250 psi) and was incorporated into a 20,685 kPa (3000 psi) system. Even though the bleed off system is open ended into the mud tank, a sudden surge of pressure, along with the column of fluid in the system, pressures can easily exceed 1725 kPa (250 psi). Surge pressures close to the rating of the pop off valve are possible until the system is bled off.

3. **Material Specifications:** The brass valve incorporated into the bleed off system had gone unnoticed during previous inspections. The brass valve was the original valve direct from the manufacturer. Brass fittings were not appropriate for this application.

Above is a photo of the failed 250 psi valve. This valve was replaced with the appropriate 3000 psi valve

1. All piping-hosing and valves materials must be suitable for the application and consistent with the pressure rating of the system in which they are installed.
2. Maintain consistent diameter piping in a relief pressure system; do not swage down piping in the system.

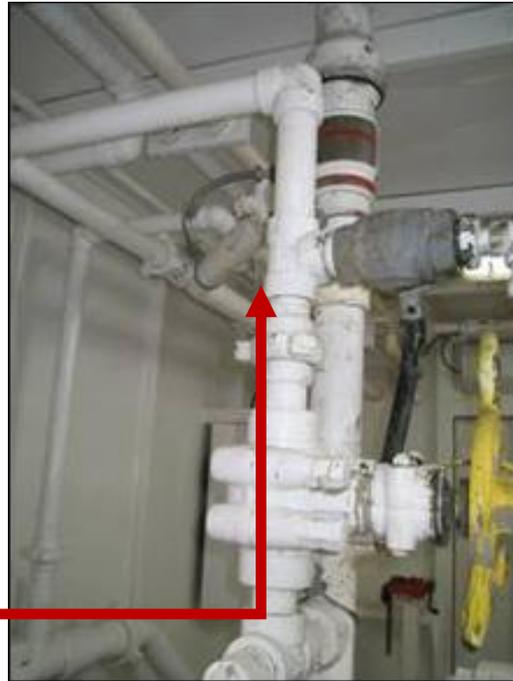
2. **System Design:** The pop valve and bleed off line is 3 inches and the high pressure hose from the outside of the building leading to the high pressure hose is 3 inch steel line; going into the tank is 2 inches in diameter. This reduction in diameter will cause an increase in the pressure in the bleed-off line. It is critical not to create any bottlenecks in a pressure relief system. Manufacturer's specifications normally require all piping downstream of the relief valve to be equal size or greater in size than the outlet of that relief valve.

3 inch bleed off line swages down to a 2 inch hose. The 2 inch hose was replaced with a 3 inch hose to eliminate the piping restriction.
