# Boomer Hook Strikes Employee

## SAFETY ALERT

ISSUE #: 07-2015

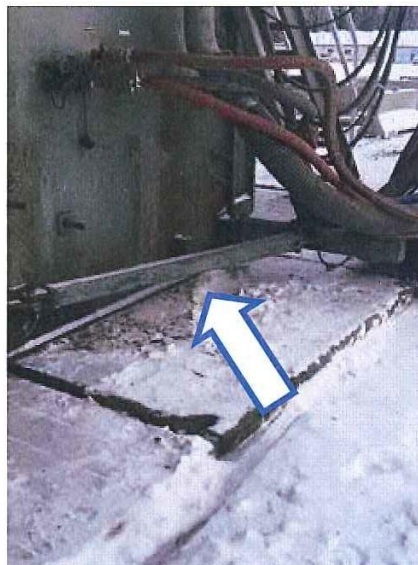
The incident occurred while walking a pad rig from one well to another. A pin pocket on the spreader bar, which pulls the suitcases behind the rig, broke. At that point, the move stopped. A chain and a ratchet boomer were attached to replace the spreader bar. This allowed workers to finish the move.

Spreader Bar

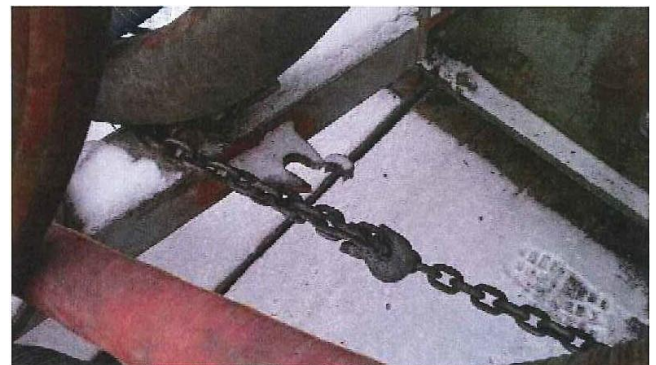
The spreader bar was not repaired prior to walking the rig again. As the crew began to walk the rig to the new well, the boomer broke. One of the boomer hooks flew over 10 meters and struck a worker. The worker's shoulder was injured from the impact.

Location of where ratchet Boomer was attached to replace spreader bar

- If a load exceeds a chain's maximum capacity, the results can be catastrophic. As a result, chains will only be used for cargo securement.
- Use Management of Change for changes to equipment where a design issue or repeat failure has been identified to ensure any potential hazards of the change have been evaluated and effective safe guards are in place.

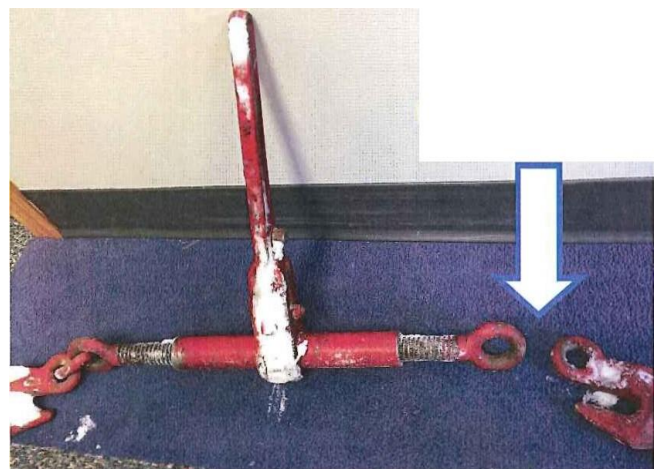
Broken Connection Link on Ratchet Boomer

- The chain was not sufficient for the forces being applied.
- The spreader bar was not repaired prior to walking the rig again.
- Ratchet boomers are designed for securement. A ratchet boomer is never to be used for any kind of towing application.
