Dropped Pipe From Side Door Elevator

SAFETY ALERT

ISSUE #: SA-2013-04

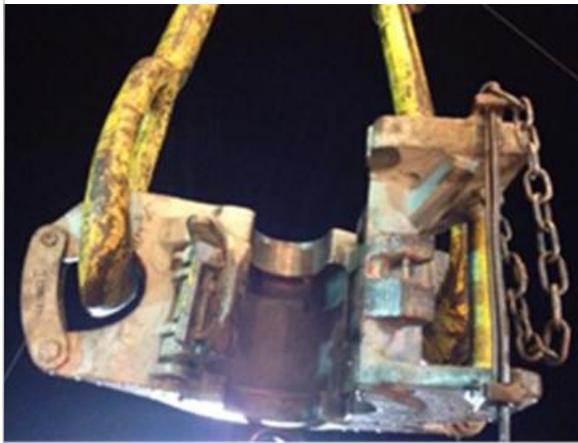
Figure 1.

- While pulling and laying down 4 1/2" tubulars the 11th joint of tubing was the next joint to be backed out, a worker closed and secured the elevators with the verification pin and the Operator hoisted the tubing up to the next connection to be broke apart. Once the connection was landed in the slips, the tongs were engaged and the connection was broke. A crew member grabbed a hold of the tubing and began to guide it to the lay down machine. The crew member was in the process of asking the Operator to hoist the tubing back up when it fell down to the stabbing mat and came to rest against the rig floor. Employees looked up to see that the elevator was open with the verification pin still in the hole that it was placed in.

- Workers were able to install the verification pin when the elevator was not fully latched.
- The latch on the elevator was either not fully engaged prior to hoisting the tubing or it came open under load during the hoisting operation.
- There was a non OEM modification made to the elevator at some point in time.

- Company Management to educate employees that operating manuals for new or unfamiliar equipment is available and/or supplier training provided and to increase crew member awareness when operating manual elevators that they are properly latched and secure prior to hoisting.
- Prepare Safety Alerts to communicate incident with all parties involved on a global basis.
- Review all Side Door and Single Joint Elevators in inventory for proper installment and function of safety latch verification pin.
