# Flammable Liquid Spill

## SAFETY ALERT

ISSUE #: 08-2015

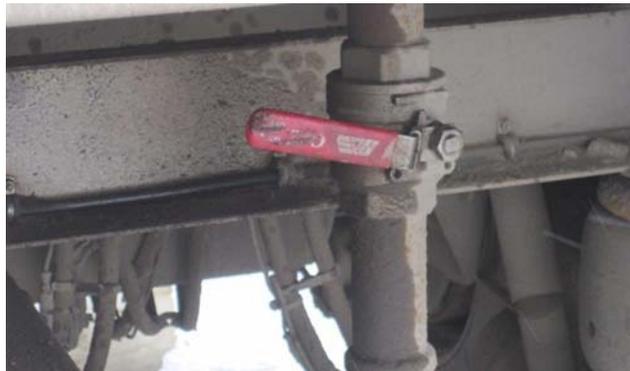
Drain valve that was left in the open position

The drain valve on the bottom of the trailer was in the open position when filling commenced.

The drain valve is not easily visible and truck personnel were unaware of its location.

- Personnel must secure equipment before and after working on it.
- Personnel must be competent to complete the tasks assigned.

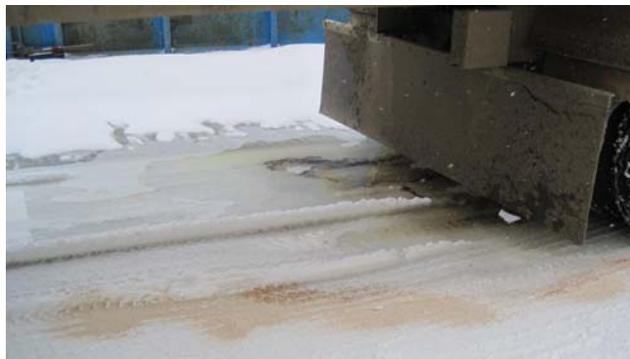
Approximately 1,458 litres of a flammable defoamer product was spilled onto the ground from a pup trailer. The spill occurred from a drain valve during the loading of the trailer. The trailer had just been flushed the previous day using the drain valve.

Showing spill on the ground
