Roloc Bell Separates from Winch Line

Minor Injury and Vehicle Damage

SAFETY ALERT

ISSUE #: 11-2011

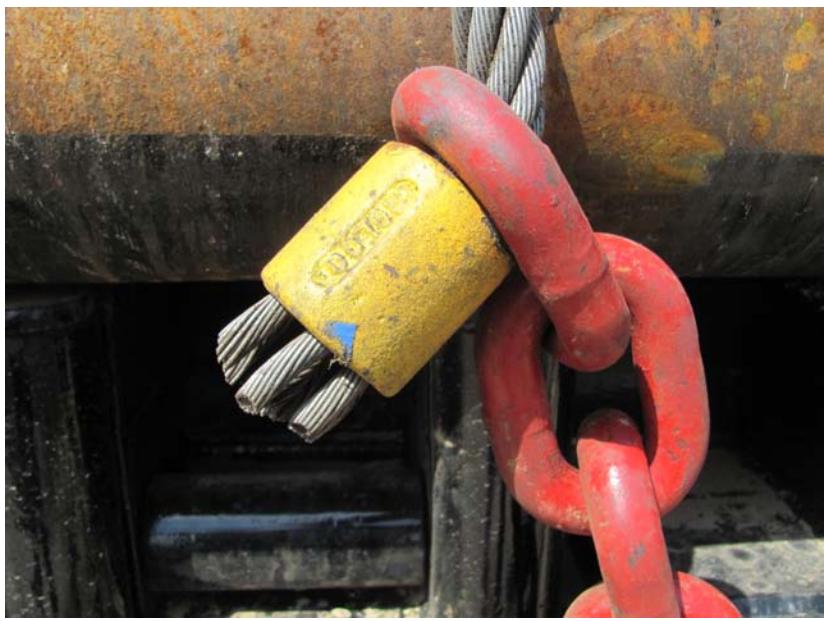
The Roloc Bell separated from the winch line while a driver was winching a light plant on to a bed trucks live roll. (See photo on page 2)

The rear window guard had been removed from the truck. The stored energy in the winch line caused the winch line to enter the cab through the rear window and exit out the driver's side front windshield. The driver was very fortunate to have only received minor bruising on his right arm.

- The Roloc Bell became separated from the winch line.
- The Roloc Bell had been replaced on only one occasion, since the winch line had been installed on the bed truck.
- The Roloc Bell was not located and the company was unable to complete a full inspection on the equipment.

- Rig Move Supervisors, Drivers and Swampers shall be familiar with winch line, Rolog Bell, tail chain and loading sling rejection criteria.
- Winch lines, Roloc Bells and loading slings must undergo pre-use and continuous inspections prior to and during winching operations.

- Develop and implement an in-cab process, where drivers can record the date winch lines, tail chains, or Roloc Bells are replaced.
- Recycle Roloc Bells, do not use more than once.

- Winching equipment, meeting industry rejection criteria, shall be taken out of service and recycled.
- Drivers should review Winching Safe Work Practice, prior to conducting winching operations.

- Owners of winch trucks shall ensure all winch trucks have rear window guards installed.
- Drivers shall be monitored, to ensure they do not remove rear window guards on winch trucks

- Drivers removing rear window guards shall have the rear window guard attached to the truck in a manner that prevents the rear window guard from being removable.
