Sideboom Stick Collapse

Safety Alert

Issue #:05-2016

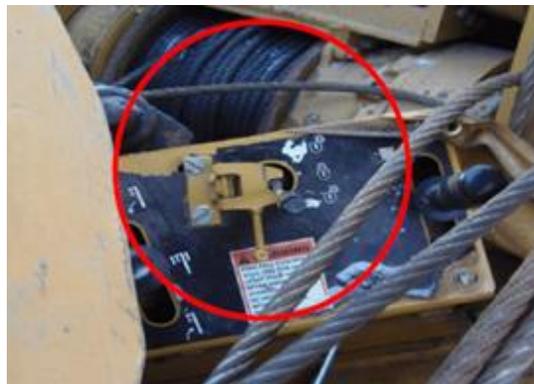
Loose Hydraulic Lockout Mechanism

Failure of the hydraulic lockout mechanism combined with unintentional engagement of the load-line lever.

- The inspection checklist did not include the lockout mechanism.
- Cold weather start-up procedures had not been established.
- The pan-headed flat drive screws used were inadequate to secure the hydraulic lockout mechanism.

- Contact manufacturer to replace screws on the hydraulic lockout mechanism with bolts and locking hardware.
- Revise daily inspection checklist to include inspections of the hydraulic lock out mechanism.
- Develop and implement cold weather equipment starting procedures.
- Investigate the use of umbrella stand holders or alternate weather protection.

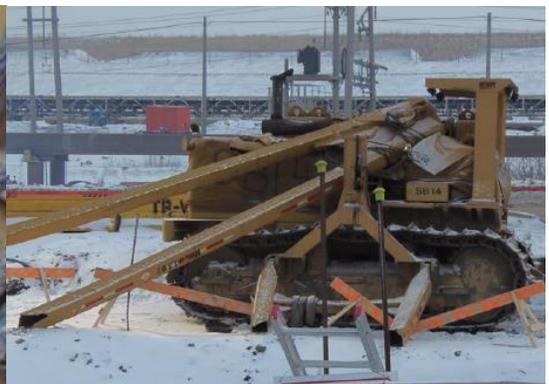
A sideboom's engine was started to warm it up during cold weather. The operator verified that the sideboom was locked out, but did not notice that the bolts on the hydraulic lockout mechanism were loose. The operator placed an umbrella over the seat and left the sideboom unmanned while the engine warmed up. The placement of the umbrella engaged the load-line lever and the loose screws on the lock-out mechanism allowed the lock to fail. Approximately 27 minutes later a nearby work crew observed the load line slowly spooling in, causing the stick to bend backwards over the canopy and subsequently break. The stick, hook and blocks fell into the cab of the sideboom.

Damaged Sideboom
