Tank Cable Strikes Employee

SAFETY ALERT

ISSUE #: 02-2014

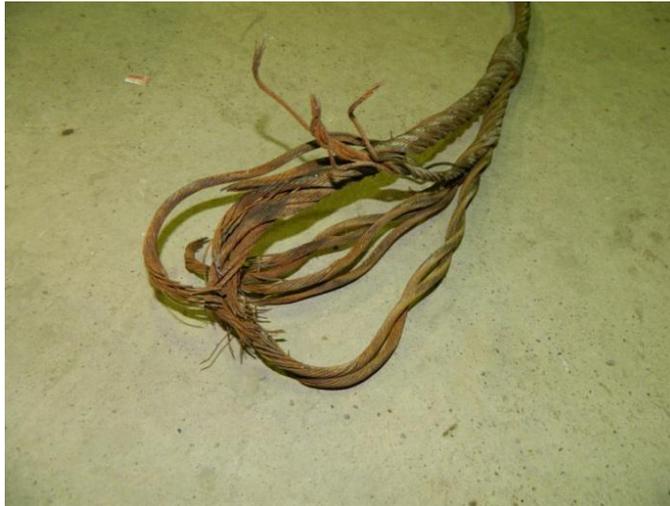
Two employees were assigned to lay down standing 400bbl tanks. Their task involved attaching a winch line to the tank cable and tipping the tank onto the bed of the truck. The bed truck with the tank attached is then moved to the desired location and the tank is unloaded (laid down) to face the lease entrance so a tractor can load the tank and haul it to location to be cleaned. The driver reversed to position the truck in front of the tank and the swamper attached the truck winch to the tank cable. The tank cable was visually inspected prior to being attached and did not appear to be faulty. As the driver began to winch the tank onto the truck, the bottom of the tank slipped (kicked) out. The tank cable broke and the winch line snapped back towards the rear of the truck cab. The winch line tail chain came through the rear window of the truck, striking the driver on the right side of his head and face. The driver was taken to hospital for examination and x-rays and was released the same day.

Broken Tank Cable used in task

- A. When winching tanks onto truck, the bottom front edge of the tank should be positioned so the tank is prevented from kicking out. This can be done by lining up the bottom edge of the tank with a slight overhang over the edge of the mat. The edge of the mat will prevent the tank from kicking out in the event that the truck fails to roll forward or the tank slips on the mat.
- B. Ensure that the cage of the rear window is always in the closed and locked position.
- C. Cables on tanks used to attach to the winch line should be inspected and replaced as necessary.

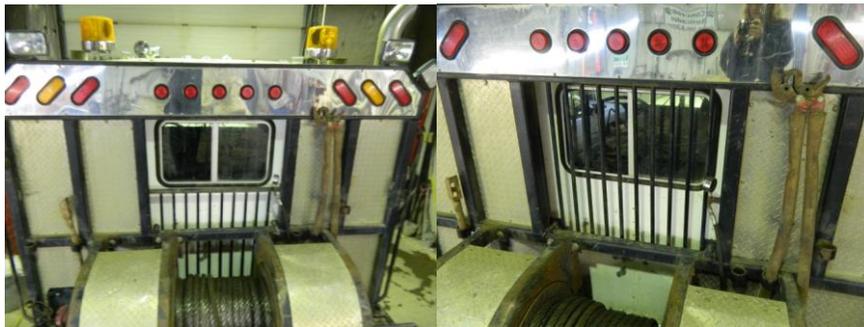
Window guard was not secured during task
