Vacuum Truck Explosion

Safety Alert

Issue #: 03-2016

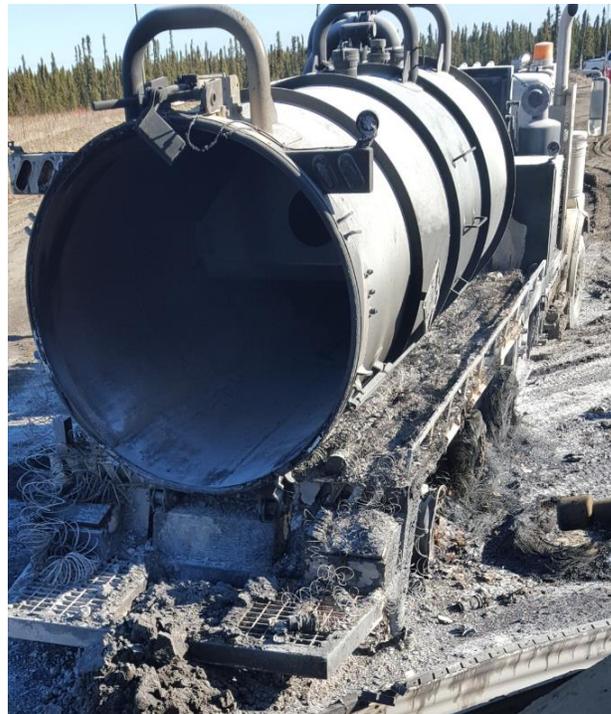
Destroyed Vacuum Truck

The blower and associated rubber hose overheated igniting the residual hydrocarbons in the blower's associated hose and piping.

- The blower and associated hose and piping can overheat such as when the blower is operating at maximum for an extended time or when under a load. Testing conducted on other trucks identified temperatures beyond the manufacturer's maximum temperature for the rubber hose.
- A review of the blower manufacturer's documentation revealed that the blower was not designed for use with flammable liquids despite the integrated presence of a diesel flush system on this truck and similar trucks in the upstream oil and gas industry.

- A temperature gauge was present on piping downstream of the blower, but it did not have a red zone. Operators were not aware of what constituted an unacceptable temperature.
- There was no engineering control device to keep the blower from overheating or to warn of an overheating condition.
- A build-up of flammable material was present in the blower's associated hose and piping.
- The operator did not use the emergency shutdown device (ESD) on the truck.

- A temperature sensor was installed on the hot side of the blower and the sensor was equipped with an audible and visual alarm.
- Operators were equipped with and trained on the use of infrared temperature meters.
- A procedure was instituted to cycle the blower on and off between 10 and 12 psi to reduce heating.
- A procedure for the inspection of the diesel flush line was created. This was not a contributing factor, but it was felt that this warranted additional focus.
- The inspection of internal piping and hoses for residual hydrocarbons was added to the regular maintenance schedule.
- Refresher training was given to operators on emergency response procedures.

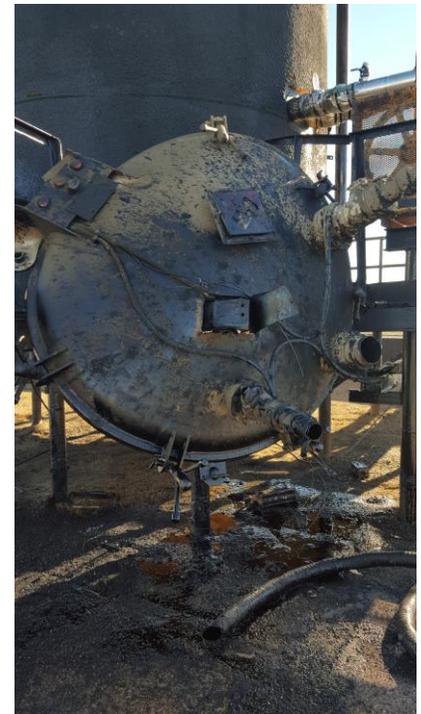
A vacuum truck operator was in the process of unloading cold heavy crude when he noticed that the 6-inch rubber hose downstream of the blower was smoldering. The truck operator proceeded to discharge his fire extinguisher on the hose and then turned off the blower and closed the truck and tank valves. Shortly thereafter a loud popping sound was heard and then the truck operator was engulfed in flames. While the operator was running away from the area the rear door on the vacuum truck blew off hitting the production tank and platform. The vacuum truck was completely destroyed and some damage to the production platform was sustained. The operator was wearing fire retardant coveralls and a 4-head gas monitor and suffered third degree burns requiring a skin graft.

Vacuum Truck Lid Resting Against Production Tank
