## **SAFETY ALERT - #20 – 2009**

### **WORKERS BURNED BY PROPANE FURNACE LEAK**

**RELEASE DATE: NOVEMBER 9, 2009**

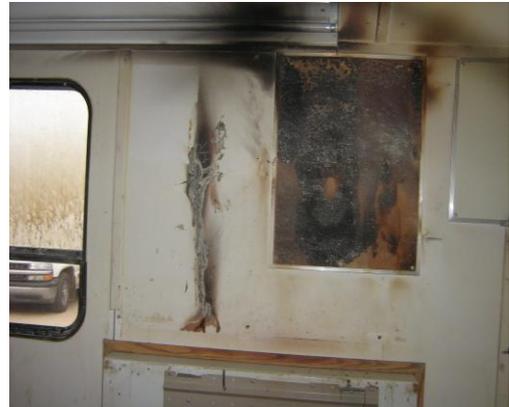
Earlier this fall, two workers were beginning their day on a lease. They arrived on site, entered their portable trailer and turned up the thermostat in order to start the propane furnace. Shortly after adjusting the thermostat, the furnace burst into flames. As the two workers were exiting the trailer, the flames caused serious, but recoverable burns to the hands of both workers.

1. The pilot line tubing had a small hole allowing propane to leak inside the trailer.
2. The pilot hole cover assembly was not installed at the time of the incident. Review of the Owner's Manual for the furnace identified that this cover was required for the furnace to operate properly.
3. An annual inspection of the heating system had not been completed, as required by the manufacturer.

1. Establish an annual, third party inspection of all natural gas or propane powered trailer heaters. This annual inspection will take place prior to the furnace being used for the cooler fall/winter season.
2. Establish furnace lighting procedures / instructions and place these instructions near the furnace thermostat.
3. Revise monthly inspection of doghouse furnace to include failed items listed above.
4. Complete training at safety meetings or rig visits to improve understanding of proper lighting procedures, monthly inspection requirements as well as the posting of the warning signage near the furnace.
5. Implement a Management of Change Procedure for documenting an equipment modification to ensure that proper review and authorization of the change takes place.
