SAFETY ALERT - #10-2009
WORKERS INJURED USING DAMAGED LIFTING EQUIPMENT
RELEASE DATE: APRIL 20, 2009

Function: Well Completions and Servicing	Incident Date: June 22, 2008
Incident Type: Struck by Operating Equipment	Country and Region: West Central Alberta

Two workers were injured when a lift sling dislodged from a winch hook that did not have a properly operating safety latch.

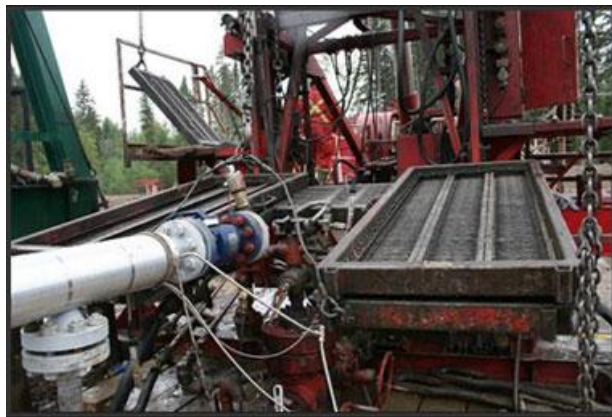
Figure 1
Resting position of rig floor post incident

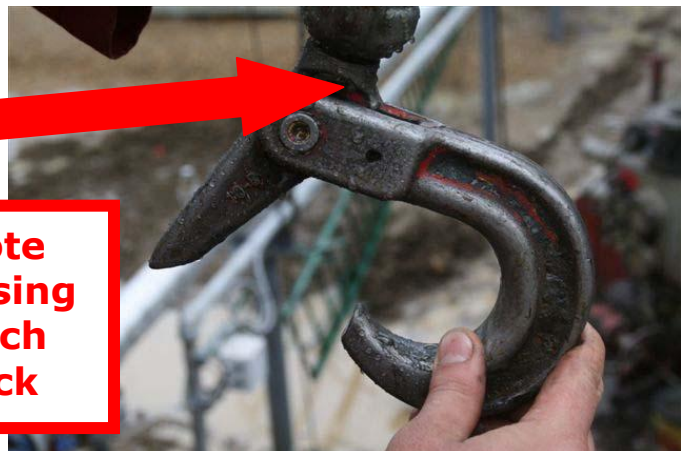
Figure 4:

8. When the rig operator began running the winch controls, the floor hand and derrick hand were standing out of the fall path of the rig floor.
9. At the time of the incident, both workers had moved below the fall zone of the rig floor before the rig floor was in position.
10. The winch hook was attached to the centre pad and an engineered sling was attached to the work floor. As the floor was raised, the weight of the floor transferred from the center pad sling to the work floor sling. Without the latch lock mechanism, the D-ring pushed out of the winch hook allowing the rig floor to fall.

Kuplex® safety hook did not have a latch locking mechanism on latch assembly at time of incident and was therefore able to open when raising the floor

- ❑ **Never use damaged equipment:** Although all members of the rig crew were aware that the winch hook was damaged, the hook was returned to service and used to raise the rig floor.
- ❑ **Always give careful thought about your proper position for the task:** In this case, both the derrick hand and the floor hand moved below the rig floor while it was being hoisted by the winch line and were standing directly below an overhead hazard.
- ❑ **Consider the need for design changes before an incident happens:** In this case, the company initiated a review the work floor design after the incident and made changes to eliminate the necessity of having the winch hook on the work floor centre pad making lifting operations much safer.
