## **A Safety Device Gone Wrong!**

June 2014

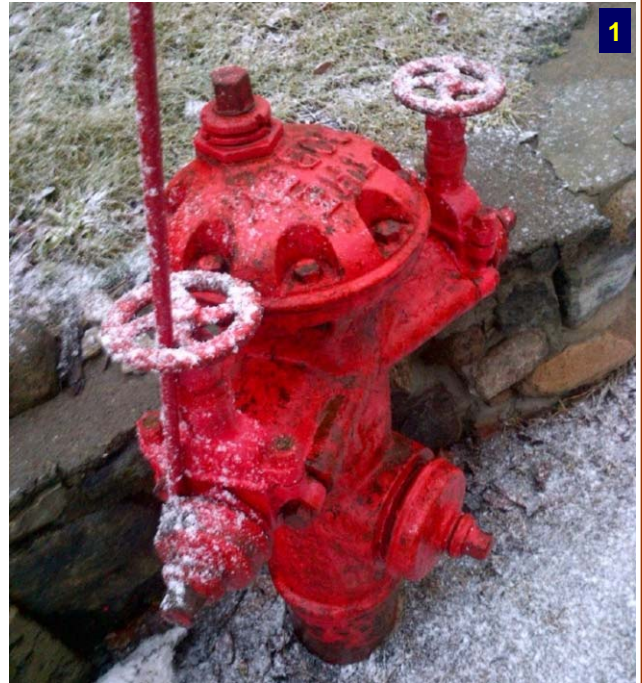
Picture 1 shows a fire hydrant in a town in the northern USA that gets a lot of snow in the winter. The vertical steel rod fastened to the left side of the hydrant is intended to mark the location of the hydrant, as shown in Picture 2. A flag is installed at the top of the rod so firefighters can find the hydrant if it is covered with snow. The flag also marks the location of the hydrant so it is less likely to be damaged by snow removal equipment, and so people do not park vehicles where they will block access to the hydrant. The flag is a safety device to help people know where the hydrant is located if it is buried in snow.

Clearly this safety device has created a problem. The metal rod was installed so that it passes through the valve handle. You cannot open the valve without first removing the rod! The rod may also impede the use of a hydrant wrench to open the hydrant. While the rod and flag can be removed, this will take valuable time, possibly in an emergency situation.

- ➔ Any change to a system, including the addition of a new safety device, is a change that must be reviewed using your plant's Management of Change (MOC) procedure.
- ➔ When doing an MOC review of a new safety device, be sure to consider the possibility that the change introduces new hazards.
- ➔ After the change is reviewed, make sure it is implemented correctly and is ready for operation using your plant's pre-startup safety review (PSSR) process.
- ➔ Get emergency response personnel involved in MOC and PSSR if the change impacts them.

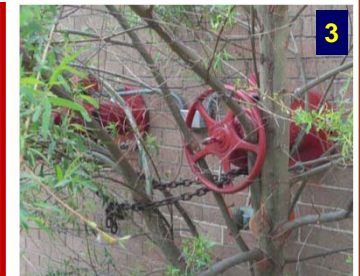
Picture 1 resembles Picture 3, from the October 2004 *Beacon*. In Picture 3, nature, in the form of a growing tree branch, makes it difficult to operate the fire water valve. In Picture 1, somebody has installed a rod and flag through a fire hydrant valve, with the same effect.
