Fireproofing Structural Supports

May 2010

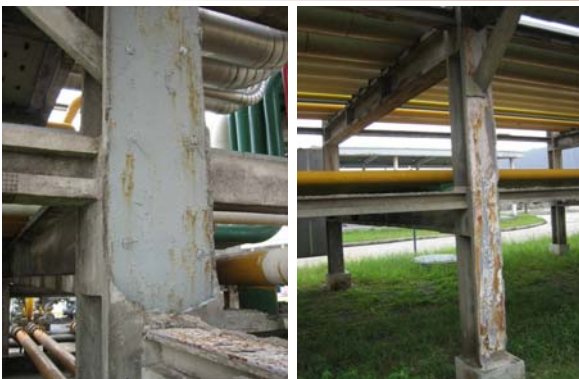
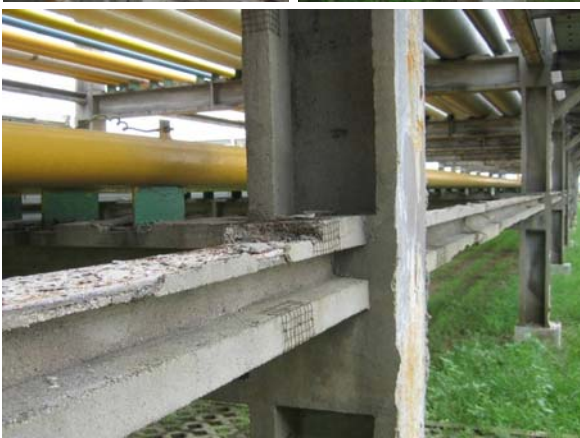
← Some examples of damage to fireproofing on steel pipe bridge supports – the fireproofing has been removed, or has become degraded and fallen off.

- As you go about your work, look for damage to fireproofing on support columns or beams for pipe bridges, buildings, outdoor process equipment structures, and other equipment supports.
- Periodically include inspection of fireproofing as a part of your routine plant safety inspections.
- Report observed damage and make sure that it is repaired.
- If you are doing any work that requires temporary removal of fireproofing on structural elements, make sure that the fireproofing is replaced when the job is finished.
- If you damage any fireproofing on structural elements in the course of other work, report the damage and make sure it is repaired.
- Be aware that damaged fireproofing can also allow the entry of water which can further damage the fireproofing and corrode the steel under the fireproofing.
