Insulation Does NOT Prevent Corrosion

February 2005

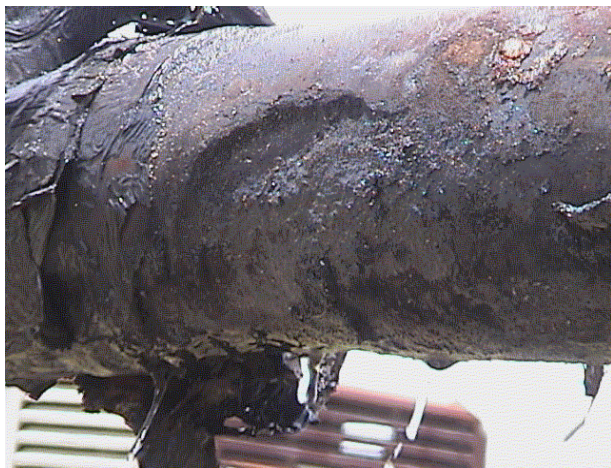
Corrosion Attacks Piping

The photograph on the left shows major external corrosion of a pipe transferring Phenol. The pipe was insulated and failed before the corrosion was discovered. Although no one was injured, it was very expensive to correct the environmental damage and make piping system repairs.

Thermal insulation and fire proofing provide the "cover" for corrosion to hide under and the right environment for it to start and grow in. This cover may trap moisture or spilled chemicals, that under certain circumstances, form corrosive conditions that attack the underlying steel. Because it is hidden from sight, the corrosion often progresses undetected for many years and may result in failure.

- Know what structures and equipment in your process have the potential for under insulation corrosion.
 - ❑ Check low points where moisture might accumulate
- Be aware of and look for the signs of hidden corrosion:
 - ❑ Rust stains or discoloring
 - ❑ Bulges, blisters or bubbles
 - ❑ Small leaks, drips or wisps of vapor or odors
- Inspect—look, but don't touch.
 - ❑ If you disturb a severely corroded area, a leak may occur. Plan inspections and, when necessary, shut down systems before removing corrosion.

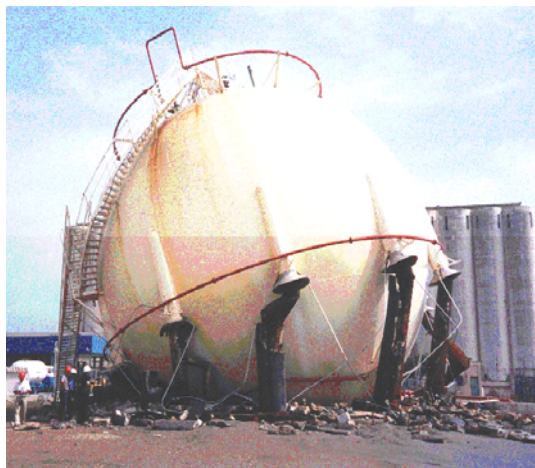
Corrosion Attacks Structural Supports

The sphere in the photograph on the right collapsed during hydro testing. The legs were fire proofed, hiding corrosion of the structural steel. When the sphere was partially filled with water, it collapsed. One person was killed and one was seriously injured.
