## Manage Temporary Changes!

October 2012

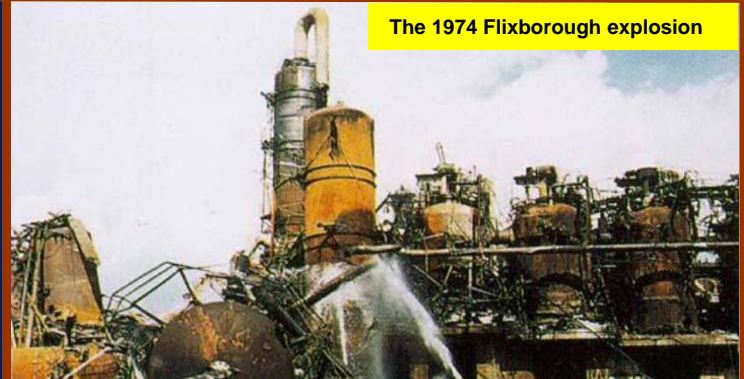
The 1974 Flixborough explosion

This incident has several things in common with the June 1974 explosion in Flixborough, England (June 2004 *Process Safety Beacon*). The Flixborough explosion killed 28 workers, injured 36, and had a major impact on process safety management systems and regulations throughout the world. The pipe which failed at Flixborough was much larger, but some common characteristics of this incident and the Flixborough explosion include:

- A management of change review was not done for a temporary piping modification.
- The temporary piping did not follow appropriate engineering standards, and the piping was not properly supported.
- Stress on temporary piping was one factor in the failure.
