Remembering Piper Alpha

July 2013

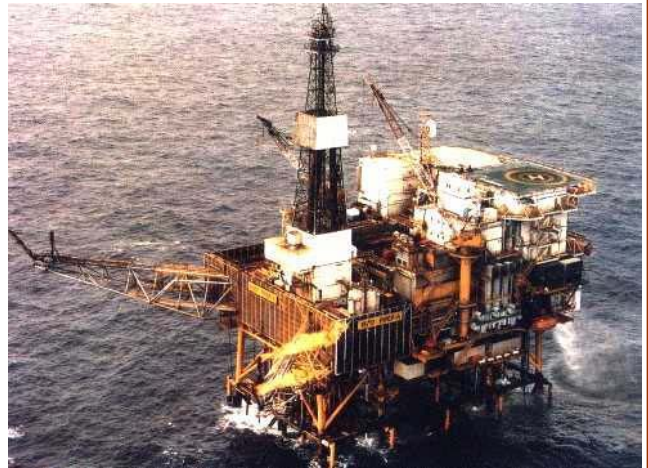
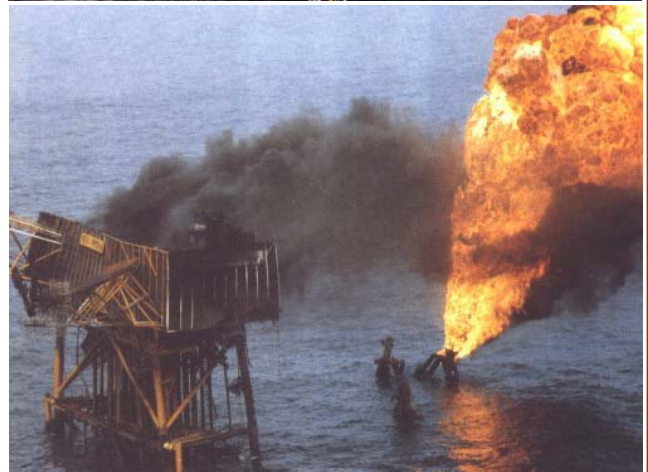
This month marks the 25th anniversary of the Piper Alpha offshore oil platform disaster in the North Sea approximately 110 miles (180 km) from Aberdeen Scotland. On July 6, 1988, a series of catastrophic explosions and fires destroyed the platform. Of the 226 people on the platform at the time of the event, 165 died along with two emergency response personnel during a rescue attempt. The platform was totally destroyed.

Investigation was hindered by a lack of physical evidence. Based upon eyewitness accounts it was concluded that a release of light hydrocarbon occurred when a pump was restarted after having been prepared for maintenance. Unknown to the workers starting the pump, a relief valve in the pump discharge had been removed for maintenance. A blank had been loosely installed in place of the relief valve at a location which was not readily visible from the pump vicinity. When the pump was started this blank leaked, producing a flammable cloud, which subsequently found an ignition source. The pump was started at about 10 PM, and by 1 AM, three hours later, the platform had been entirely destroyed and most of its occupants had been killed.

➔ **Shift turnover and communications.** During shift turnover, the status of the pump work was addressed, but no mention was made of the relief valve work. The relief valve work was also not mentioned in the control room or maintenance logs. Continuing problems with the adequacy of turnovers and log entries were a problem known to some workers.

- ***Be complete in documenting the status of all equipment in your plant logs. At the end of your shift, clearly communicate the information to the incoming workers. Take the time to make sure they fully understand the status of all operating equipment, and the status of all maintenance jobs.***

➔ **Work Permit System.** The work permit system was not consistently implemented according to procedure. For example, omission of important information such as signatures and gas test results was common. Operations representatives often did not inspect the job site before suspending the permit at the end of the shift or when closing the permit indicating the work had been completed. Craft supervisors often left permits on the control room desk at the end of a shift rather than personally returning them to the responsible operations representative as required by the procedure.

- ***Always follow work permit procedures exactly as required, including all documentation, communication, and record keeping. Do not take short cuts, and be sure to personally check everything on the permit. Never assume that things have been done correctly – if you are going to sign the permit, check it yourself.***
