What is supporting your equipment?

February 2013

Support your pipes and equipment!

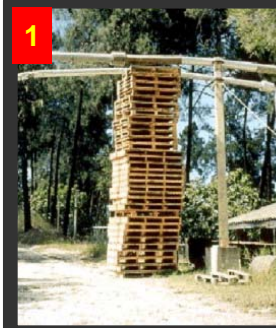
You will recognize **Picture 1** from the November 2012 and January 2013 issues of the *Beacon*. It is an obvious example of badly supported piping. But sometimes problems with inadequate support of piping and other equipment are not so easy to see.

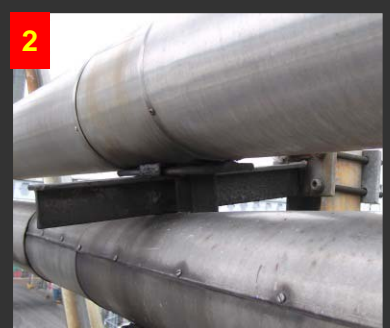
Picture 2– The steel supporting the pipes has bent, possibly because the weight of the pipes is more than the steel can support. Perhaps this was a result of a change – was a second pipe added without considering the design of the supporting steel?

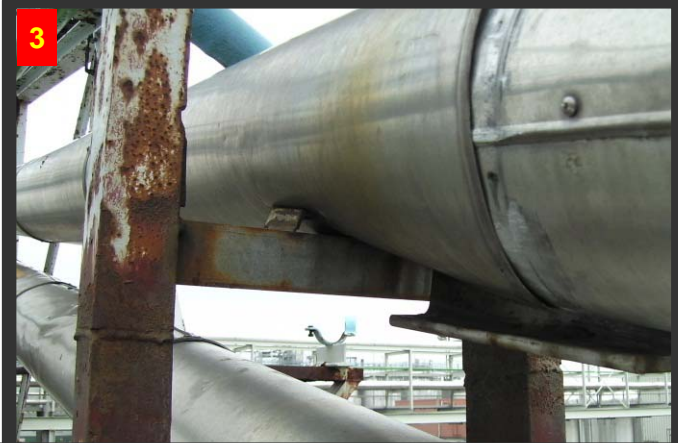
Picture 3 – The pipe has moved horizontally and the pipe support stand has moved out of the support shoe.

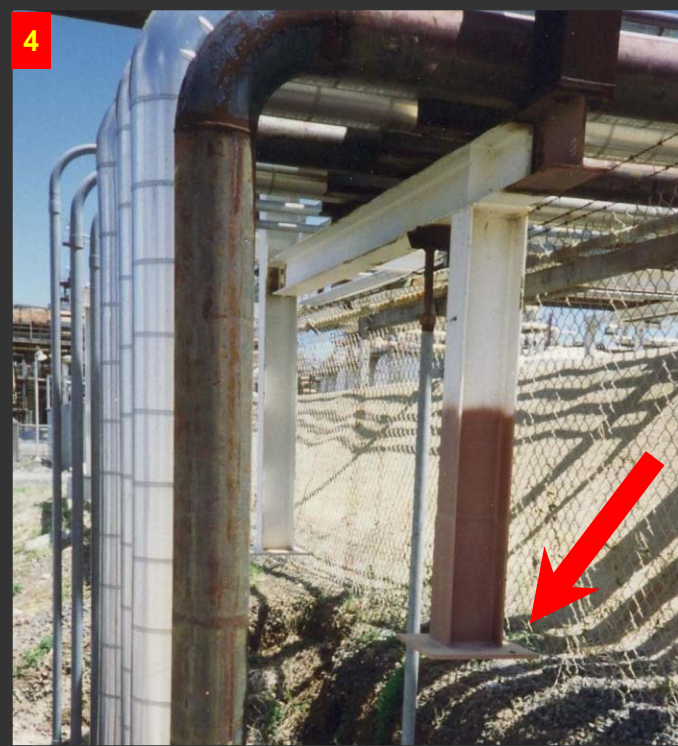
Picture 4 – Look closely – the steel supports are not touching the ground. They are hanging from the pipes rather than supporting them!

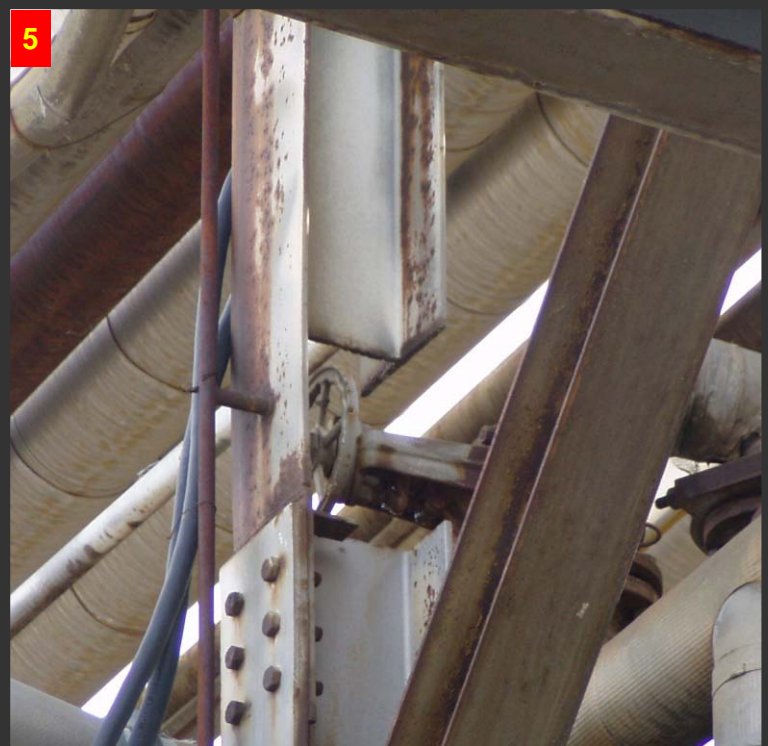
Picture 5 – Somebody has cut out a section of the structural steel to make room for a valve!
