SAFETY ALERT - #13 - 2009
ARC FLASH INCIDENT – No Loss
RELEASE DATE: SEPTEMBER 9, 2009

Function: Production Facility	Incident Date: April 23, 2009
Incident Type: Non Injury	Country and Region: Western Canada

An arc flash occurred when a technician touched two exposed lugs of a 480-volt main breaker in a Motor Control Center (MCC) while performing commissioning checks.

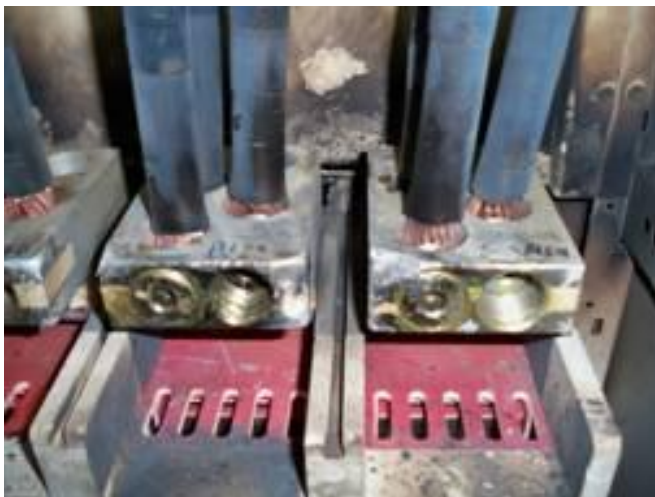
During the course of commissioning a new 480v MCC, a contract technician was required to perform phasing checks on the exposed lugs on the line side of the 480v main breaker. The technician was using a commercially available set of phase sticks with a shepherd-hook style end. When the technician attempted to check the phase C lug, the hooked end of the phase stick came in direct contact with both B and C phase lugs. Spacing between the lugs was approximately 1". As per manufacturer's specification for this voltage, there were no barriers between the lugs. The resulting contact caused an arc flash.

Phase B and C Lugs after the incident

- Review and enhance contractor selection process to ensure that training standards and procedures have been established for electrical contractors performing energized electrical work.
- Develop an Arc Flash Hazard Study standard consistent with industry standards. Ensure that all analysis are conducted in accordance with this standard and that the results are communicated to personnel performing maintenance work.
- Revise/enhance Company standards and training program to address arc flash and electrical shock hazards.
- Work on energized electrical equipment is a critical task and requires that a Field-Level Hazard Assessment (FLHA) be completed before beginning work.

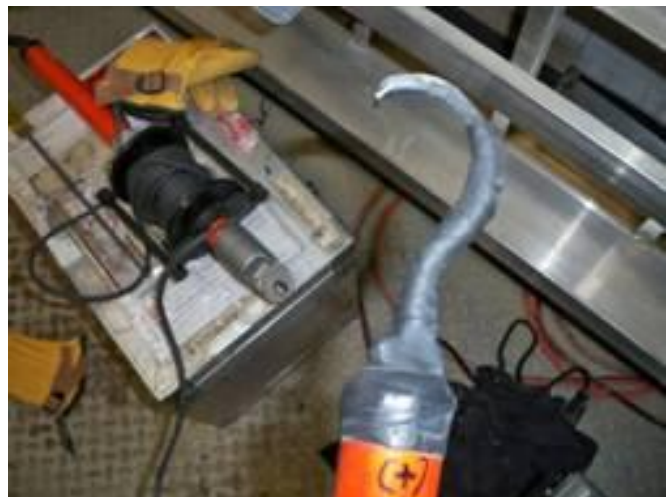
Phase Stick Hook Used to Check MCC

- The 'shepherds' hook style phase stick was designed for testing overhead lines and was not the appropriate equipment/tool for checking this equipment.
