Pressurized waterline strikes worker

Safety alert

Issue #: 11-2015

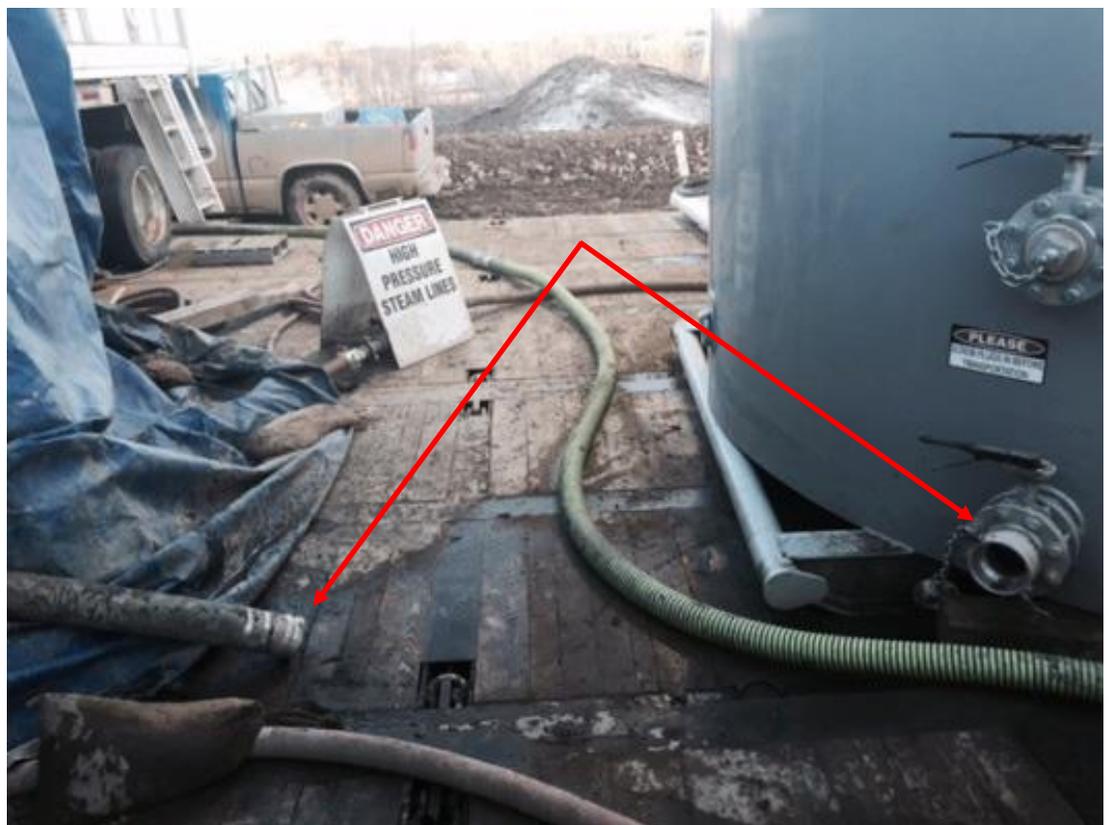
A waterline was being pressurized to sweep fresh water from the line so that it would not freeze over the weekend or be released onto the matting and create a slip hazard. One worker was pressurizing the waterline while another was at the tank waiting to disconnect the waterline from the tank. The worker at the tank asked if he could make the waterline disconnection over the radio and was instructed by the other worker pressurizing the waterline that he could proceed. The worker made the disconnection and the waterline was still pressurized resulting in the waterline hitting the worker in the leg.

Arrows show location where hose landed and location on tank where hose was attached.

The waterline was pressurized when it was disconnected.

- Inadequate communication between the worker disconnecting the waterline and the worker who was pressurizing the line.
- The worker did not check that the waterline was depressurized.
- The workers felt rushed at the end of the work week.
- No written work procedures/checklists existed for the task.
- No whip checks were present on the pressurized hoses.

- Eliminate the need to pressurize hoses by draining the water from the hoses to the ground in a controlled manner. The ability to eliminate the need to work with pressure offsets the increased potential for a slip hazard.
- Develop written procedures for the task and conduct field level hazard assessments.
- Install whip checks on hoses that are pressurized.
- Allow adequate time for workers to secure site at end of work week.
