Trucker Overexertion

Safety Alert

Issue #:16-2016

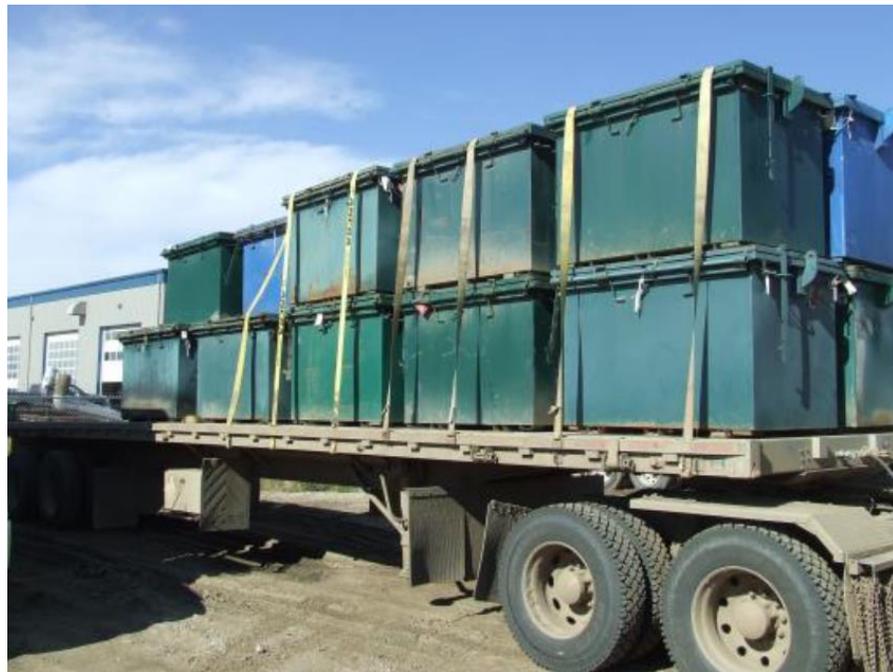
An oilfield service company that conducts trucking activities had multiple truckers who sustained shoulder muscle strain injuries due to overexertion. After a review of the incidents, it was identified that the overexertion injuries occurred when the truckers secured the cargo with load straps.

Example of bins on flat deck

- Conduct warm-up and stretching activities prior to work and after long periods of sitting/driving
- Bend knees and use leg muscles to reduce the throwing force
- Use an underhand throw whenever possible to reduce the stress on the shoulder
- Use a distance from the load of four to six feet for underhand throws and seven to nine feet for overhand throws
- Use loader assisted wrapping techniques or load taglines whenever possible
