Unsecured "A" Leg Upset

SAFETY ALERT

ISSUE #: 04-2014

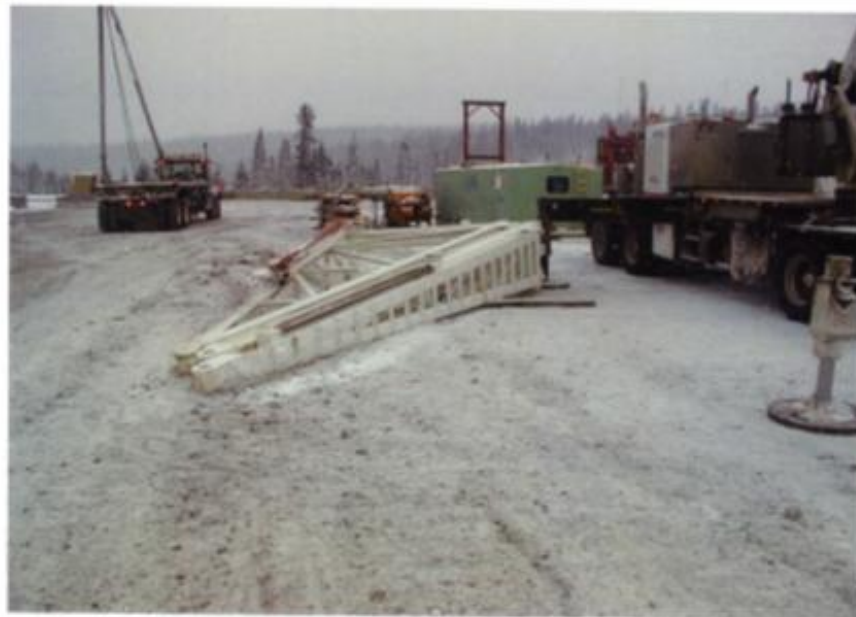
Rigging was removed from the "A" leg, and as the pole truck pulled away, the "A" leg fell over towards the picker outrigger, away from the pole truck, striking the ground and sliding into the outrigger.

Damage to the "A" leg included bending and fracturing of the steel.

No injuries occurred during the incident, although there was high potential for body contact due to the proximity of the swamper while removing the rigging. There was no movement of the picker outrigger or any damage to it, as the "A" leg only made light contact.

When the “A” legs do not have a skidded specialized carrier to provide secure vertical stability, the “A” legs will ONLY be left unattended in the following circumstances:

1. The “A” legs are cross chained in the vertical position to provide stability and are on a mat placed for that purpose.
2. If there is no way to secure in the vertical position, the “A” leg will be laid down by the crane, pole truck, or picker truck and handled and rigged in a horizontal position.
3. If no “A” leg carrier is available, “A” legs will be placed in the horizontal position while unattended and rig racked or while being transported.
