**SAFETY ALERT - #12 - 2009**  
**WORKER FATALLY INJURED AFTER BEING CAUGHT IN POWER TAKE OFF**  
**RELEASE DATE: AUGUST 28, 2009**

<b>Function:</b> Oilfield Trucking	<b>Incident Date:</b> March 12, 2009
<b>Location:</b> Onshore	<b>Location Detail:</b> Wellsite
<b>Incident Type:</b> Caught in Operating Equipment	<b>Country / Region:</b> Saskatchewan

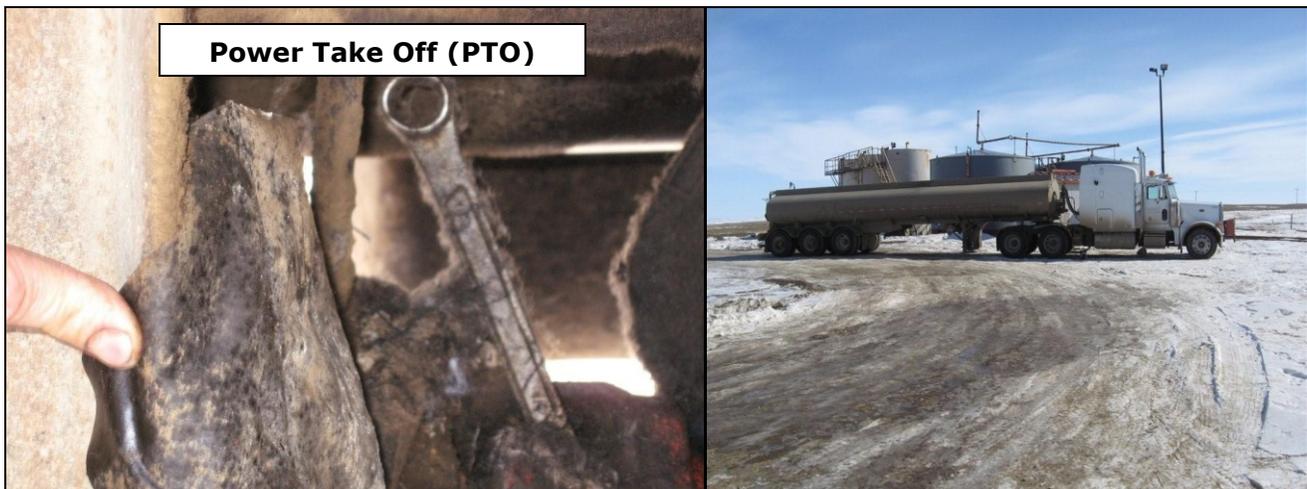
A contract truck driver was taking longer than usual at the site, so the co-owner of the trucking company went to the site to investigate. The driver was found caught in the Power Take Off (PTO) under the truck with his arm severed. The Emergency Response Plan was implemented, the scene secured and the worker was provided appropriate medical attention.

- Establish and enforce working alone practices including hazard assessments and procedures
- Ensure the training of employees includes a detailed review of the potential hazards.
- Where practical, ensure that guards are placed on all moving equipment such as PTO's.
- Ensure all safety measures including 'Lock Out/Tag Out' are taken prior to working near potentially hazardous mechanical equipment such as PTO's.
